# GENEVA COLLEGE

## PRESERVATION PLAN

*prepared by*  
**PITTSBURGH HISTORY &  
LANDMARKS FOUNDATION**  
*consultants*

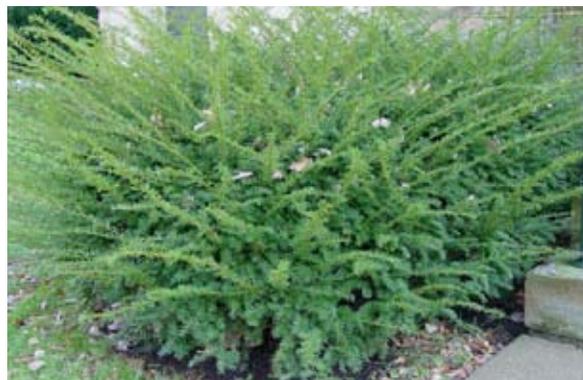
Example of a Yew allowed to grow unencumbered in its natural shape. Prune, don't shear.

manicured and improperly pruned. Discontinue shearing shrubs. Hand pruning and thinning should be instituted instead to let plants fulfill their natural shapes.

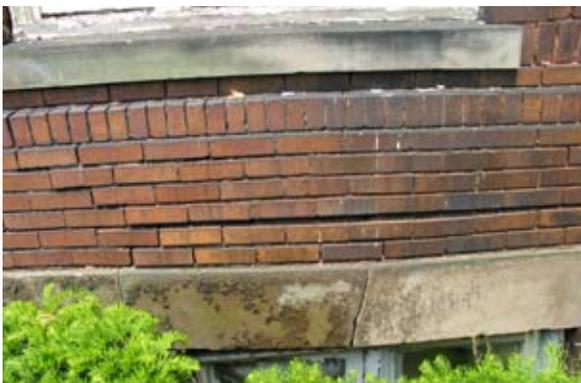
Please note that movement and structural issues are in need of attention. Evaluate and schedule repair work as soon as possible.
