PRESERVATION PLAN

SETON HILL UNIVERSITY

GREENSBURG, PENNSYLVANIA

Prepared by
**PH PITTSBURGH HISTORY &
LF LANDMARKS FOUNDATION**

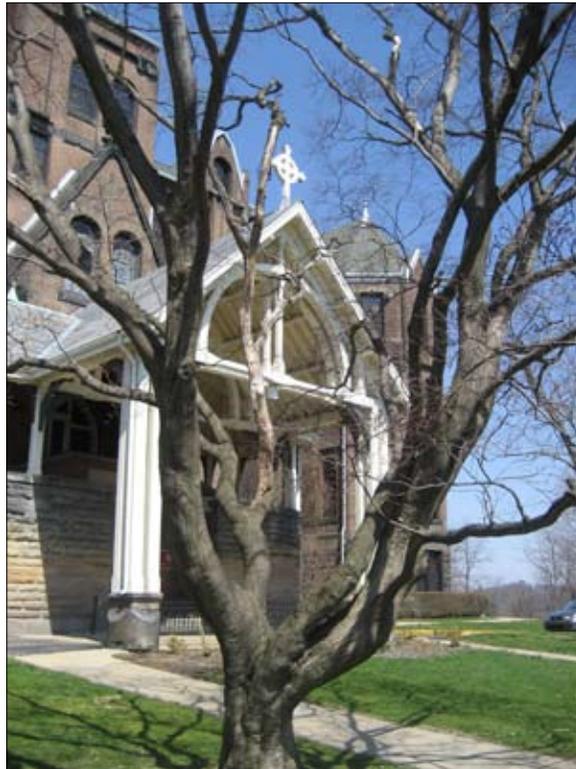
A large red-leafed Japanese maple has dead branches and rot advancing toward the main trunk. Prune dead wood at branch collars to allow the tree to seal its wounds.

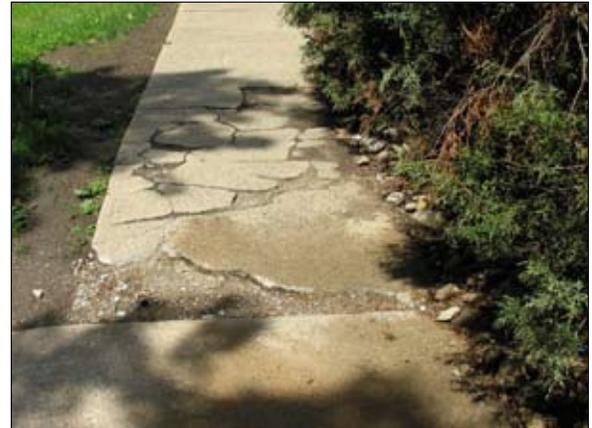
Sidewalks that require repair

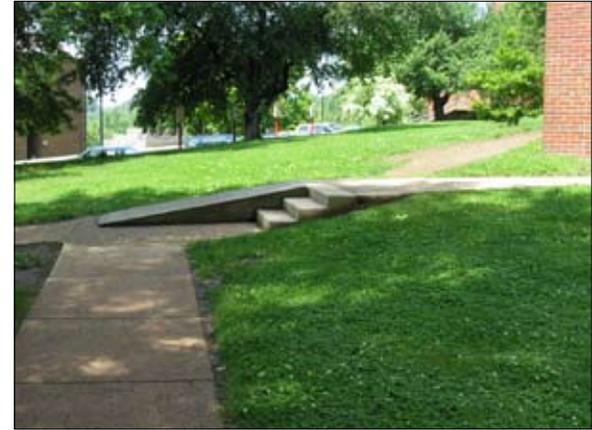
Stairs missing handrail

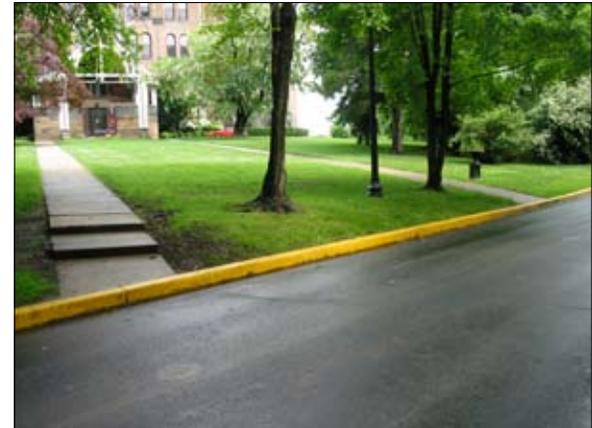
Missing curb cuts

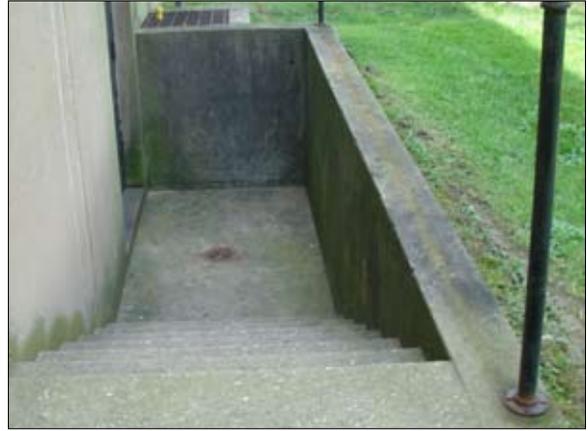
Stairs missing handrail

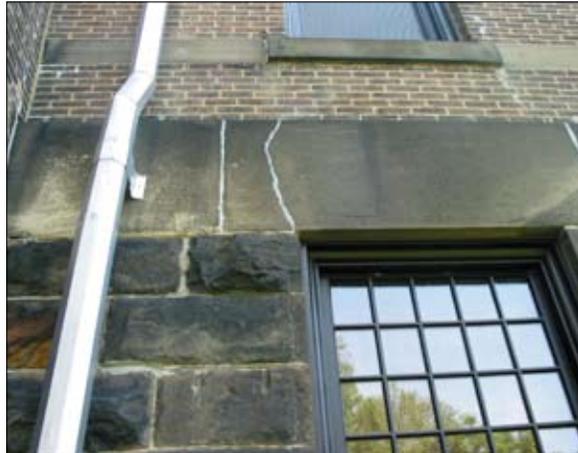
Repairs of stone masonry should match stone in color and texture.

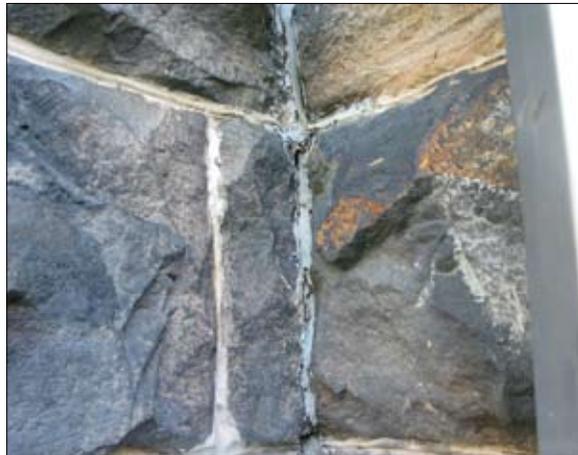
Repairs of stone masonry should match stone in color and texture.

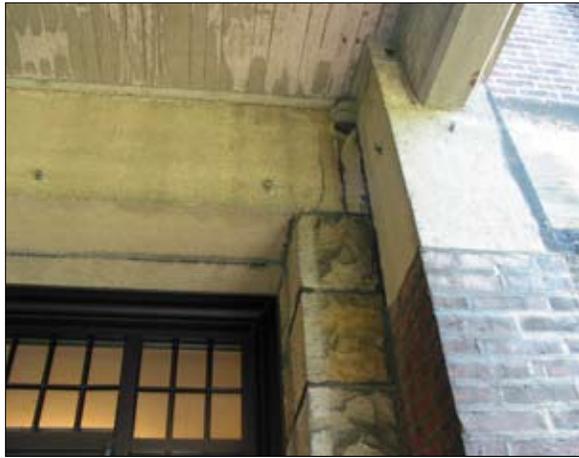
Repairs of stone masonry should match stone in color and texture.

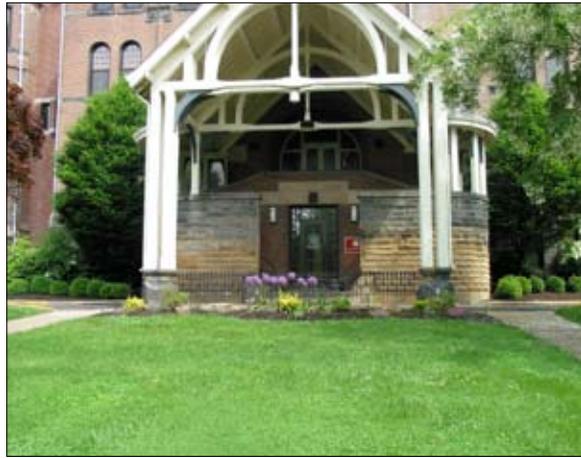
Consider continuing downspouts so that rain water flows into flower bed and not onto walks .

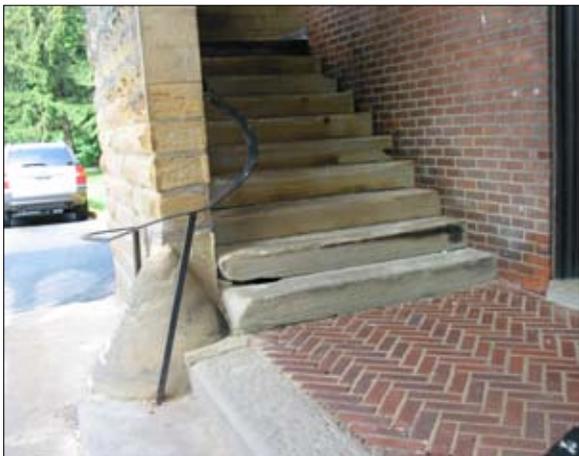
Pump grout into voids of stone stairs. Consider flipping or turning stairs that are damaged on a particular side.

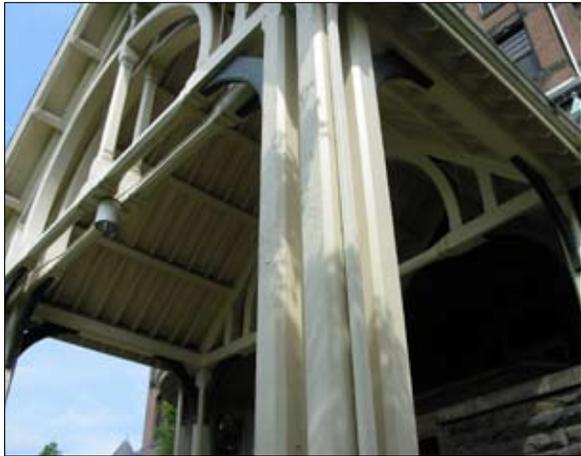
Scrape, prime and paint the portico timbers and roof framing.

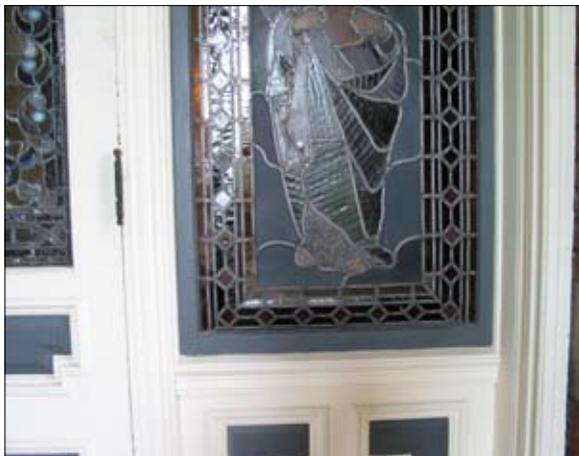
Repair ties in stained glass to eliminate bulging.

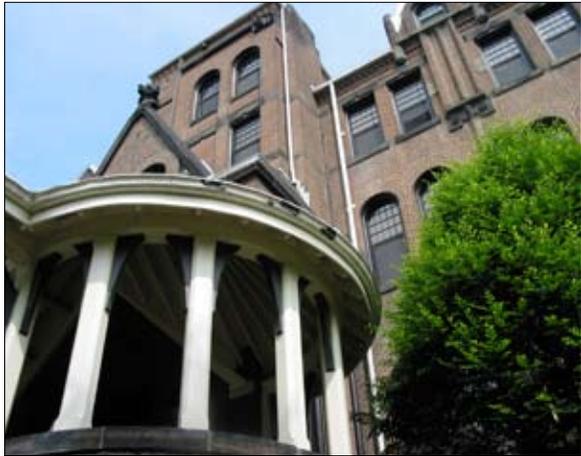
Consider removing the paint from the copper gutters and allowing them to age naturally.

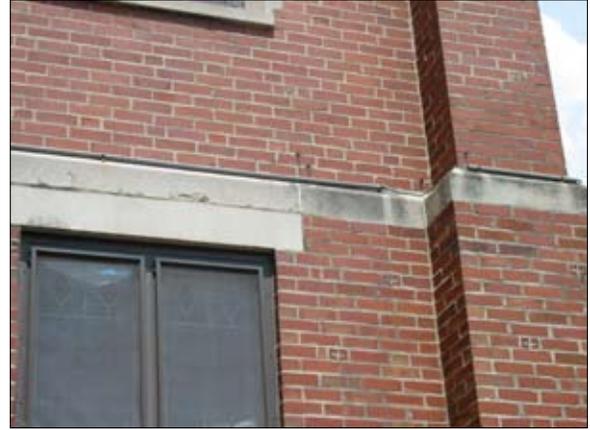
Remove abandoned hardware, repair holes.

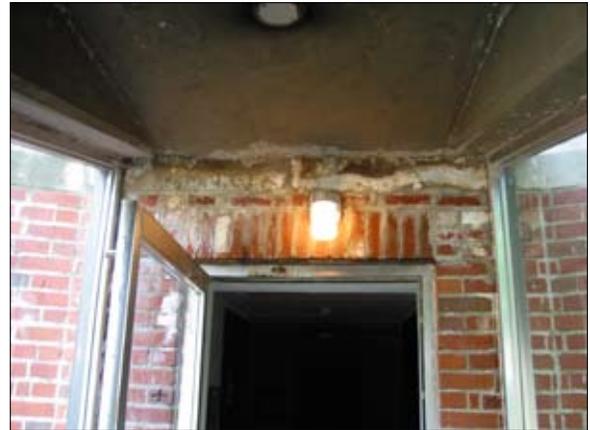
Damaged concrete.

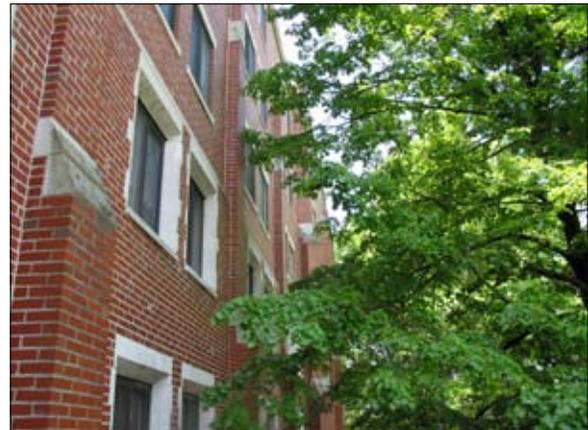
Prune trees from windows and roof lines.

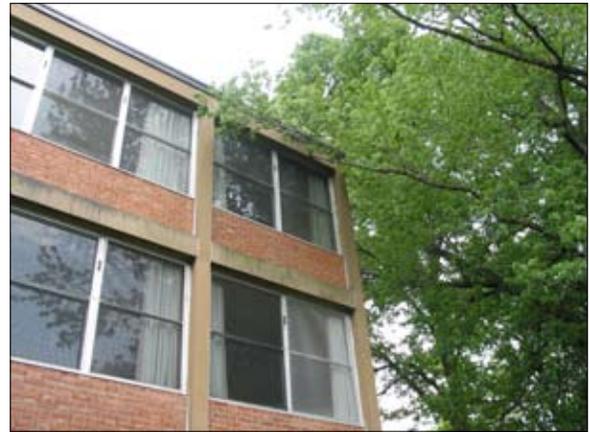
Prune trees encroaching on roof and masonry

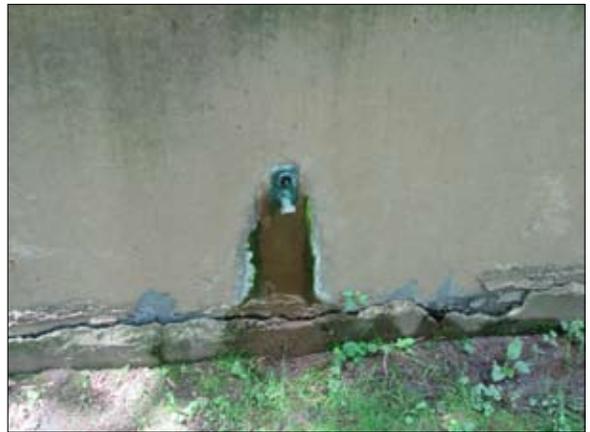
Minor leak can create larger problems

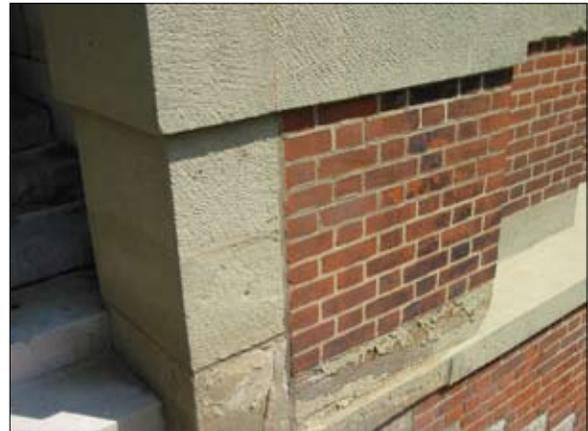
Replace with stone or repair decorative cement overlay

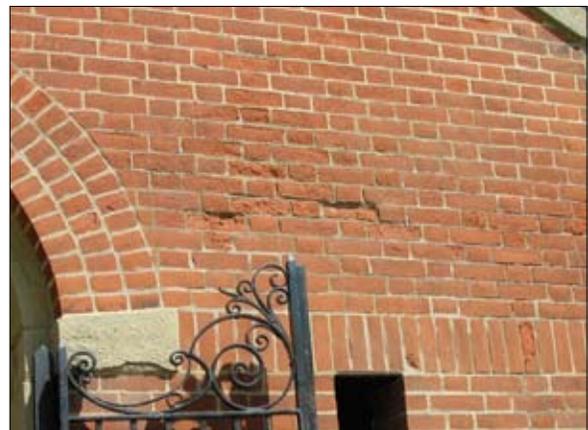
Do not use abrasives or sealers on brick or stone

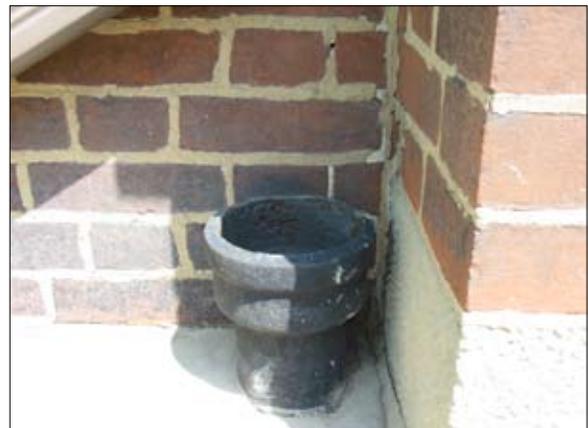
Consider painting new downspout to match existing

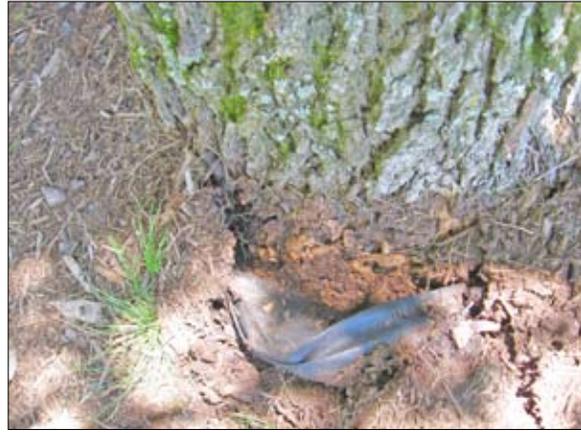
North-Sweetgum trees have mulch and landscape fabrics at base. Bark beneath is beginning to rot. Remove landscape fabrics and pull mulch back from base of trees so flare of tree is visible.

Sweetgum fabric

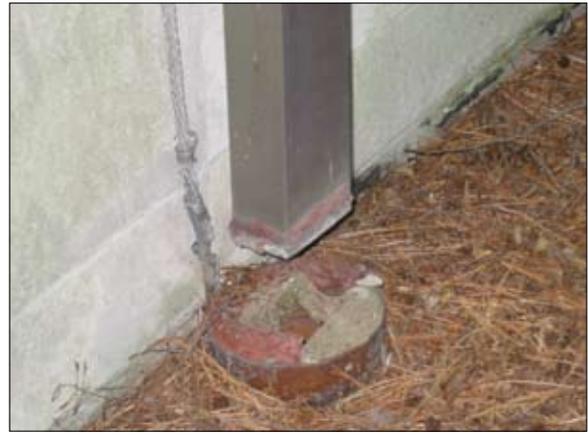
Reconnect downspout to rain leader

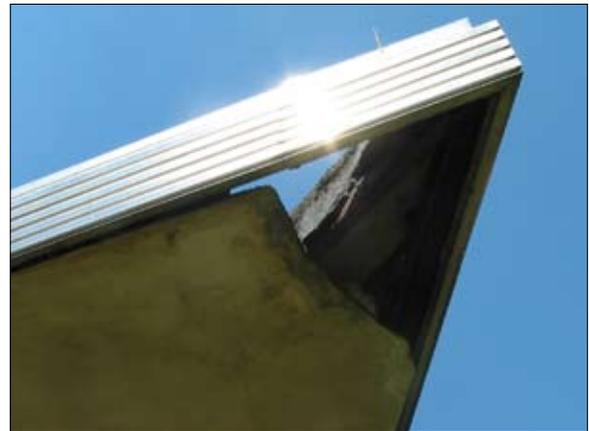
Repair roofing

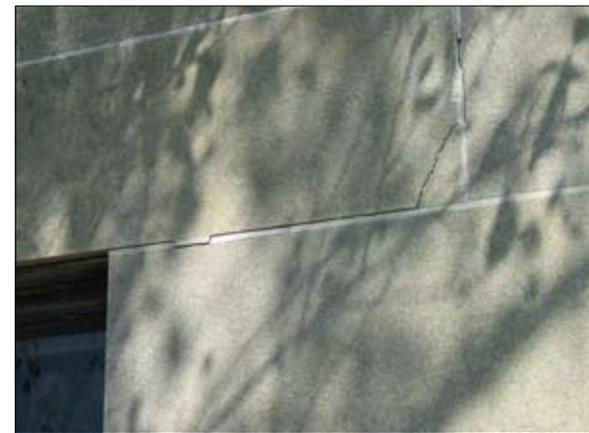
Re-point and match masonry color and texture

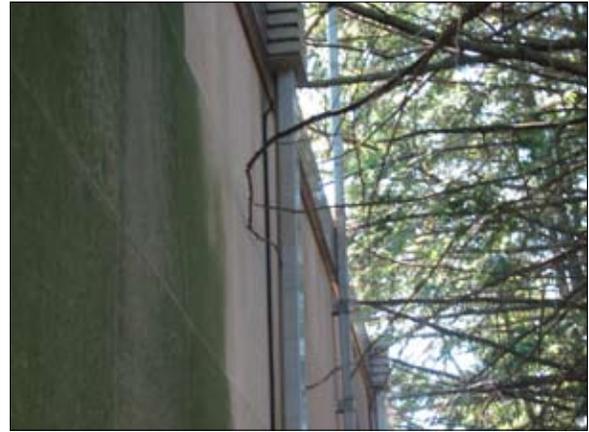
Prune back trees from roof line

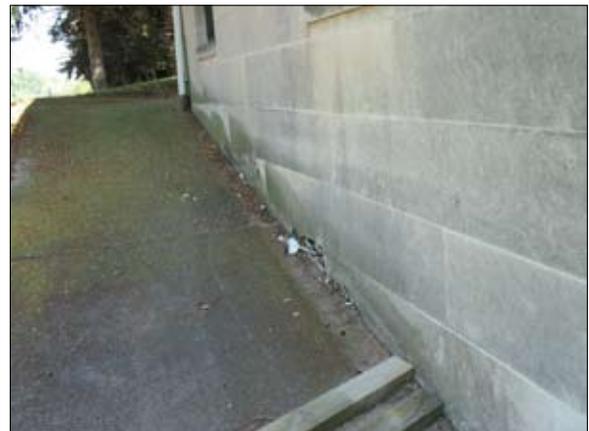
Restore walks to drain water away from foundations

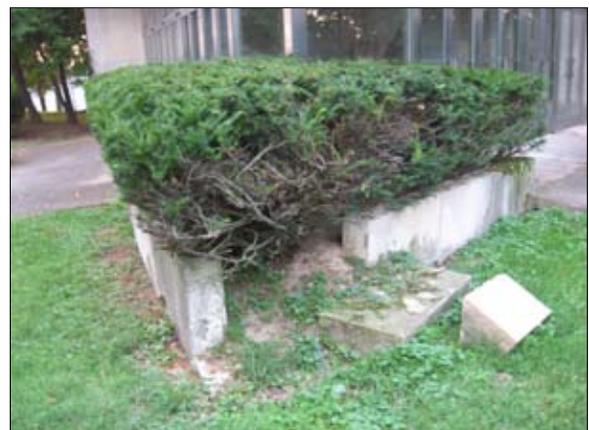
St. Philomena stone planters in need of repair

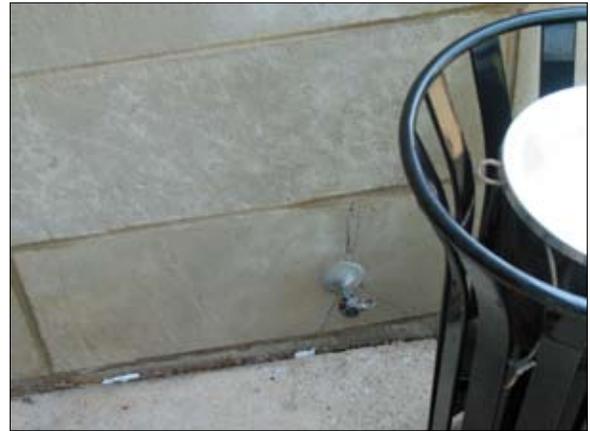
Repair stone as needed with proper material

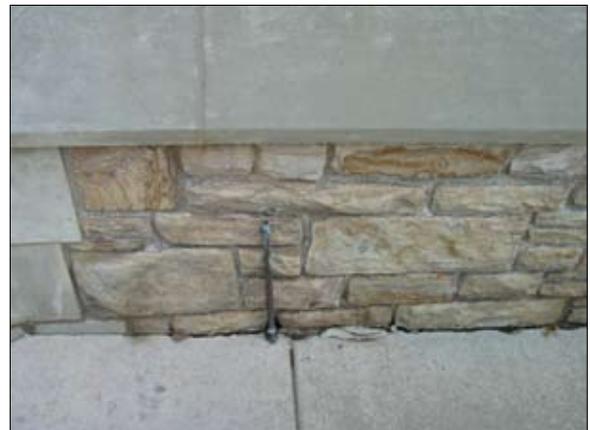
Remove abandoned copper tubing

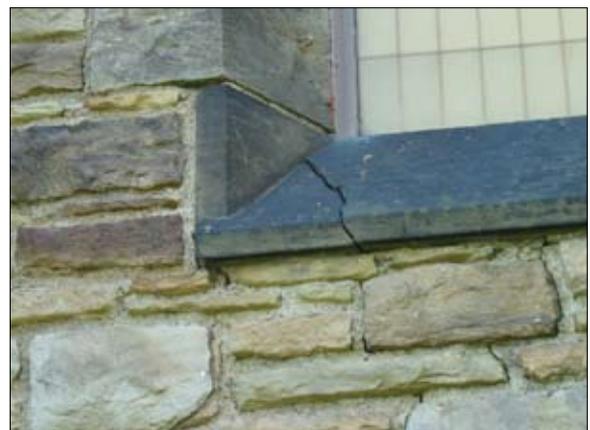
Repair stone window sills

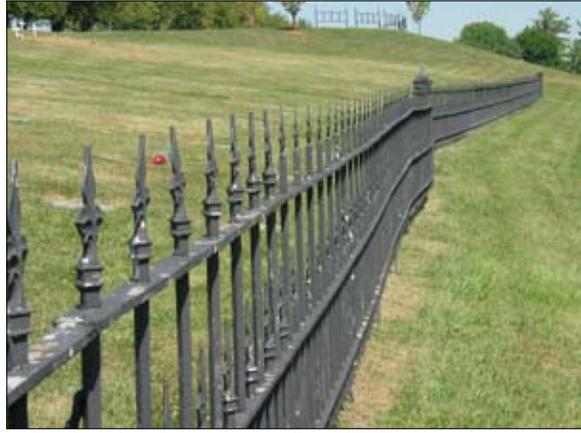
Adjust iron fencing to make it straight and plumb

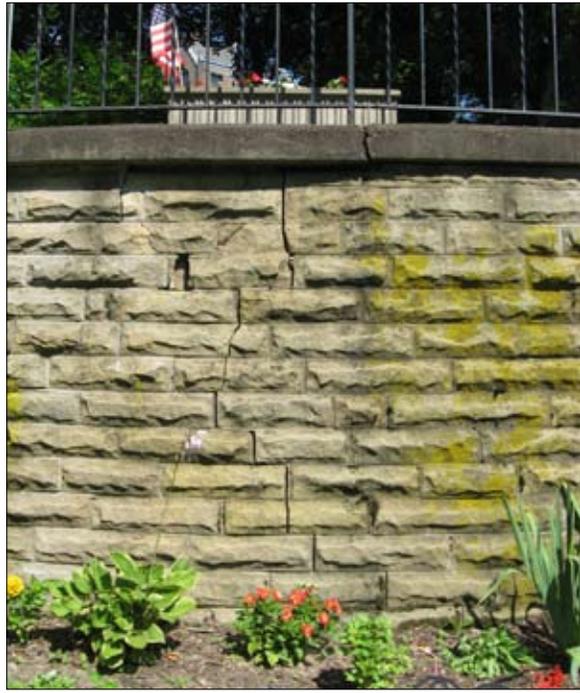
Patio low spot, wall cracks

Consider adding an evergreen hedge along the base of the patio wall.
