# GENEVA COLLEGE

## PRESERVATION PLAN

*prepared by*  
**PITTSBURGH HISTORY &  
LANDMARKS FOUNDATION**  
*consultants*

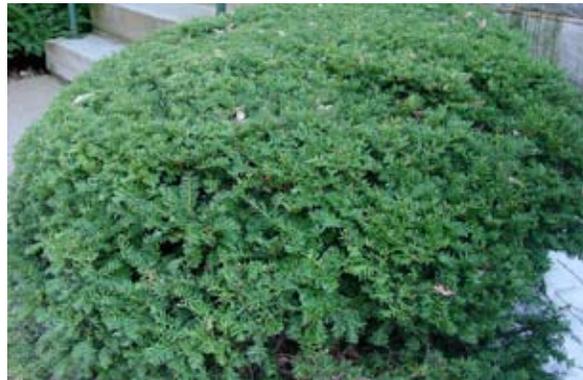
The majority of plantings are overly

Example of a Yew shrub that has been over-manicured into a "gum ball," an unnatural shape of this plant.

manicured and improperly pruned. Discontinue shearing shrubs. Hand pruning and thinning should be instituted instead to let plants fulfill their natural shapes.

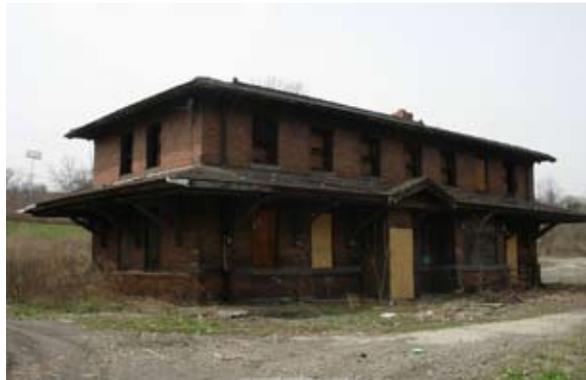
View of College Station from river trail side

- Repair of existing main tile roof.
- Restoration of canopy roof.
- Removal of first-floor rear addition.
- Restoration of exterior doors and windows.
- Restoration of site including reinstallation of original train platform area and lighting.
- The interior can be adaptively reused to suit the intended office use. Retain and restore historic woodwork including window and door trim, baseboard, chair rail, and picture rail.
- We recommend that the historic configuration of waiting rooms and station master's office on the first floor be maintained.
- On the second floor, the historic east / west corridor with track side offices should be retained and restored in any reuse plans.

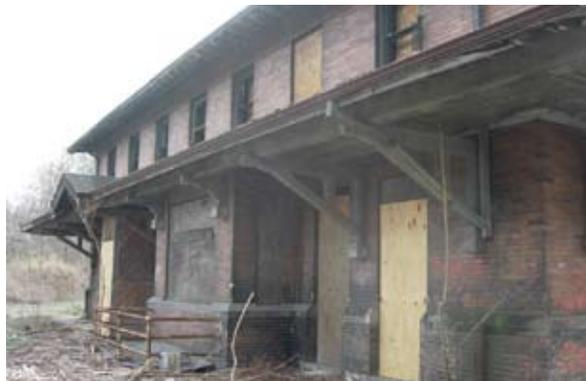
Detail of first-floor canopy

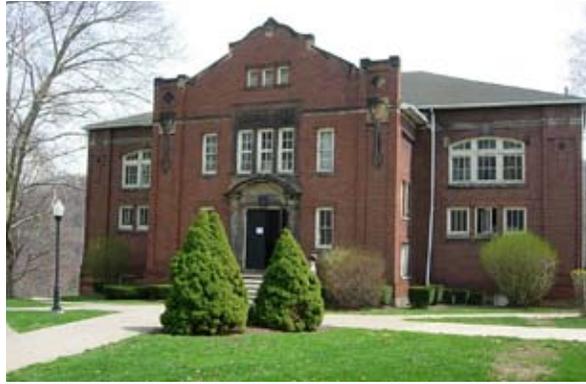
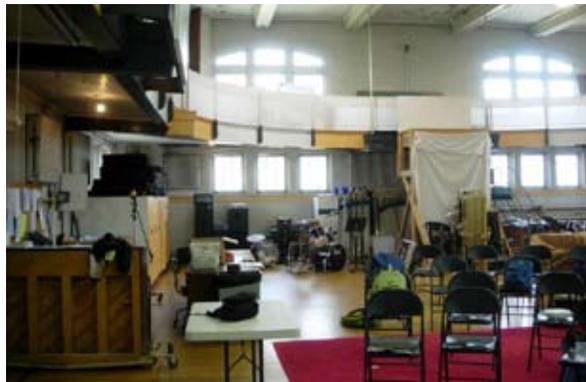
Front view of Johnston Gymnasium

Any reuse plan should replace the original tile roof, restore the exterior masonry and windows, and retain the open volume of the gymnasium space.

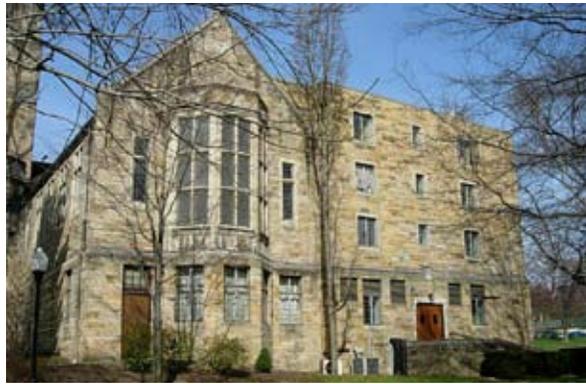
East elevation

**Lintel replacement.** The steel lintels at the north wall and at most basement windows have rusted and are deformed. These should be replaced with new galvanized lintels with appropriate weep details.

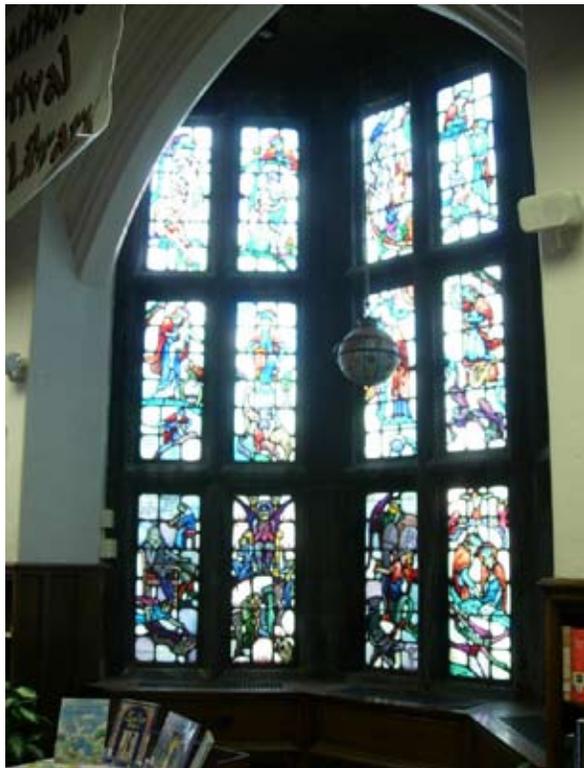
Detail of Willett designed windows

**Stained glass.** The stained glass should be reviewed by a stained glass conservator. The report should examine the condition of the steel frames, lead caming, and stained glass and identify a recommended program of preservation and repair.

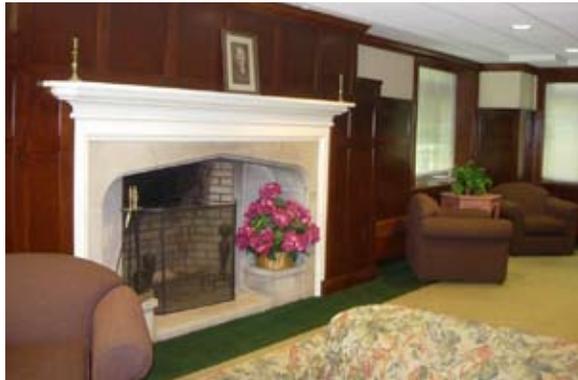
First floor lounge

**Lounge ceiling.** The original drawings show a decorative plaster ceiling in the lounge. Consider uncovering and restoring this ceiling in future restoration projects.

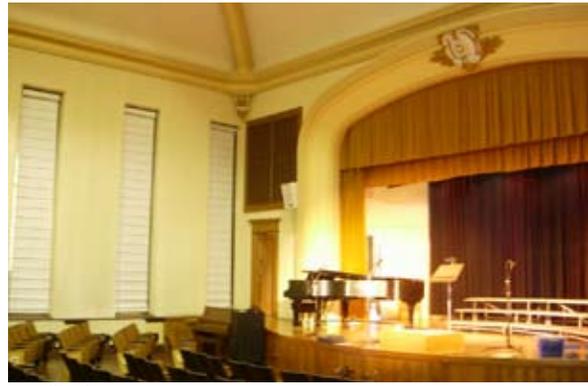
Auditorium

**Historic Interior.** The building retains a great degree of its historic interior detailing, especially on the upper floors. The second-and-third floor halls with decorative staircases, wainscoting, and woodwork appear to be original from 1881 while the auditorium retains its character as remodeled in 1915. Even the upper level classrooms, while simple, are evocative of Geneva College's earliest days. In any reuse plan, we encourage the retention and restoration of these spaces and details.

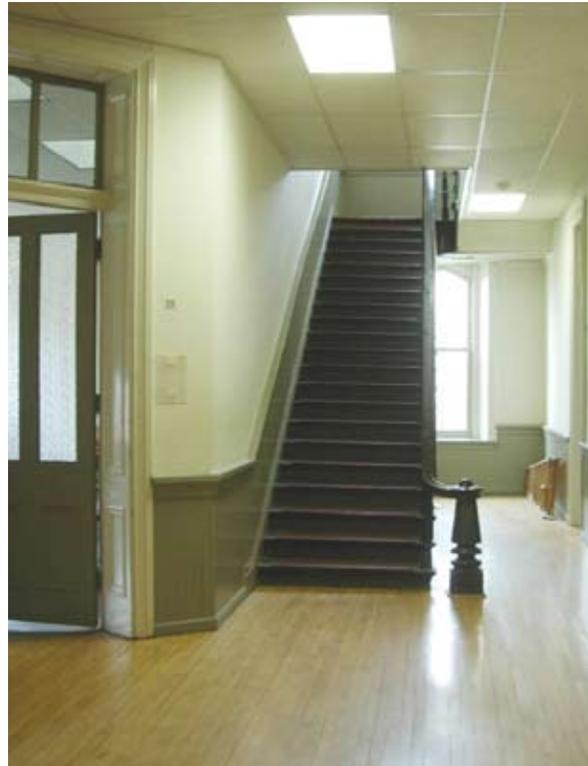
Second floor hall with original stair

Depending on the extent of future work, it would be useful to consider incorporating the restoration of the historic stairs from the main level to the second floor into a future building restoration program. It would also be useful to explore the third-floor ceiling areas to determine if any historic detail remains from the Literary Society Rooms that may have once occupied the space.

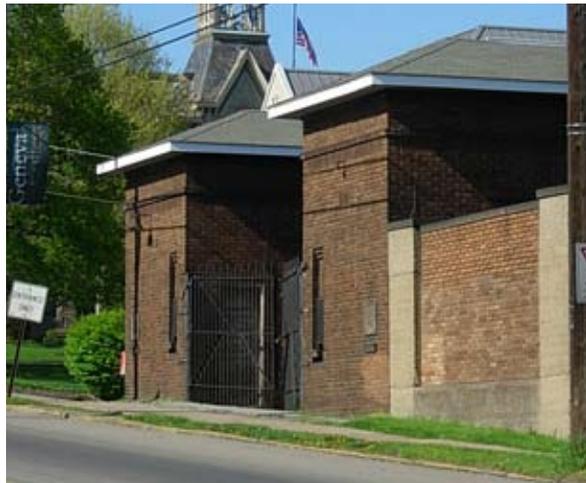
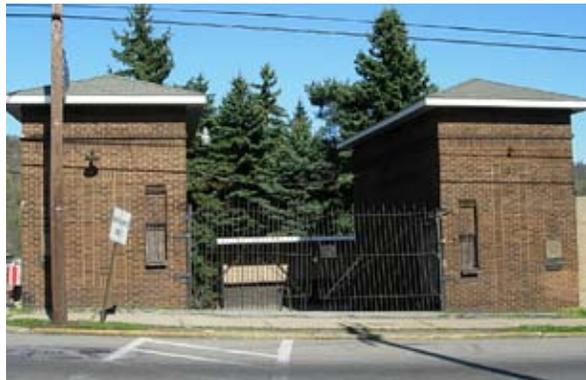
Reeves Field entry pavilions

Reeves Entry pavilion detail

- Consider restoration of the pavilions including restoration of original windows and doors and recreation of the original roof soffit and cornice.
- Research original drawings in greater detail to determine location and design of original entry gates.

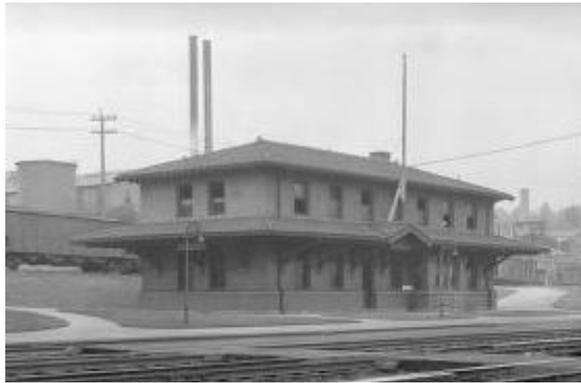
The building has been altered by the addition of a one-story storage room on the west elevation and likely interior partition wall changes within the first floor south waiting room. The exterior lighting fixtures shown in early photos no longer exist.

View of College Station from the P&LE Archives dated July 17, 1918.

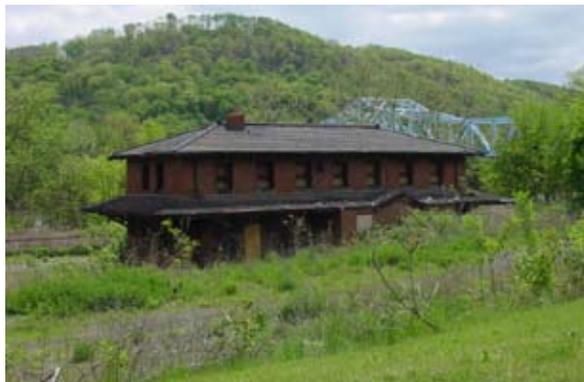
Overgrowth

Remove Overgrowth

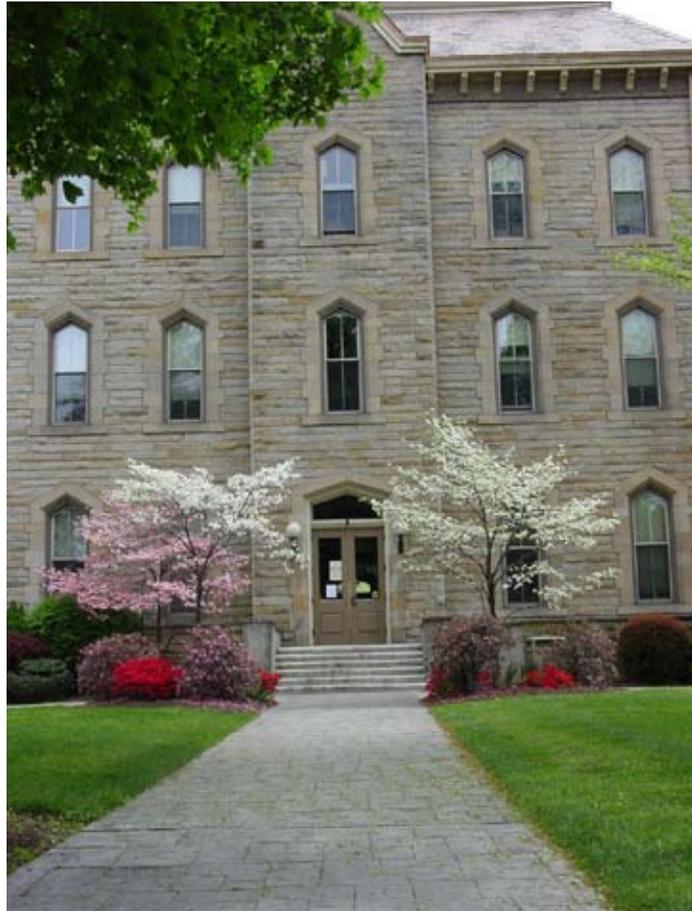
### North

- Weeping beech is a nice specimen and a good campus tree.
- Ferns do little to camouflage air conditioning units which are prominent.
- Planting area in need of edging.
- A number of dead plants noted in yew hedge.

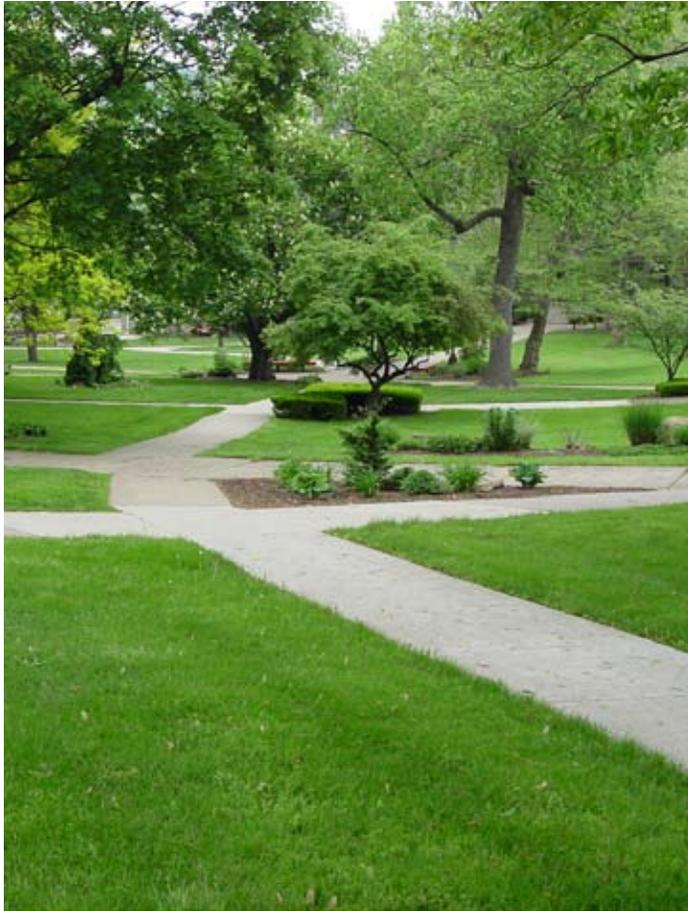
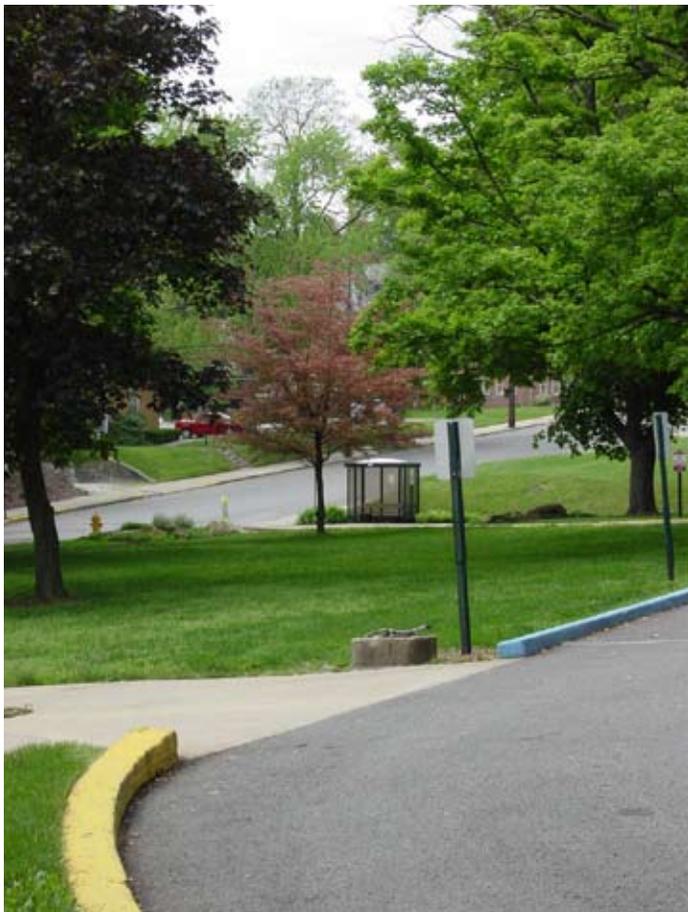
- Silver maple is 50% dead and has no central leader.
- Two Siberian elms in good condition but in need of thinning. One is possibly diseased as evidenced by the proliferation of water sprouts and sap residue.

- Walnut in good condition but contains dead wood.
- White oak is diseased (probably oak wilt). Will probably die within 2 years.
- 2 Norway maples and ginkgo left of sidewalk to Old Main are in good condition but need thinning.
