PRESERVATION PLAN

SETON HILL UNIVERSITY

GREENSBURG, PENNSYLVANIA

Prepared by
**PH PITTSBURGH HISTORY &
LF LANDMARKS FOUNDATION**

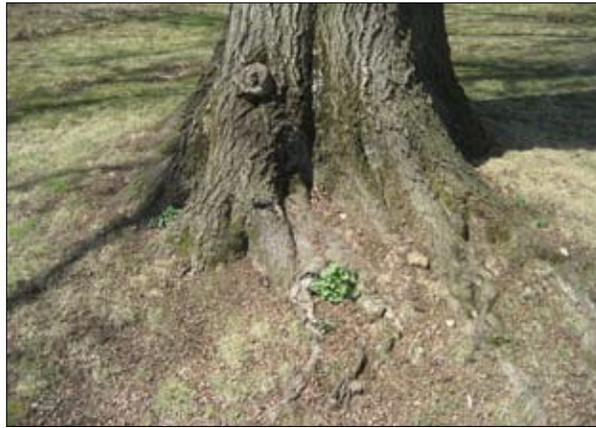
Root Flare

Trees should have a natural flare where the trunk enters the ground. If a tree comes straight from the ground like a telephone pole, a problem is evident. Possible issues include mulch that is too thick, mechanical damage to the trunk, a tree planted too deeply, or girdling roots. All can create serious problems to tree health and should be corrected whenever possible. The Airspade is a useful tool to

excavate root collars without damage to the trees. Resolving root flare issues will extend and improve the life of campus trees.

Trees should have a clear area around the root flare to lessen the potential for damage from mechanical equipment. A mulched area should encircle mature trees to prevent damage to exposed roots.

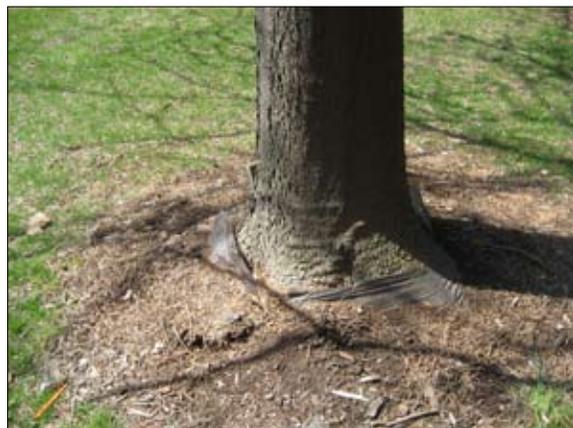
Landscape fabric

Landscape fabrics interfere with the breakdown of organic mulches (worms and insects can't get through them). They can also interfere with root growth and their removal is recommended whenever possible. Planting of ground covers would help keep weeds down while lessening the need for both mulch and landscape fabrics.

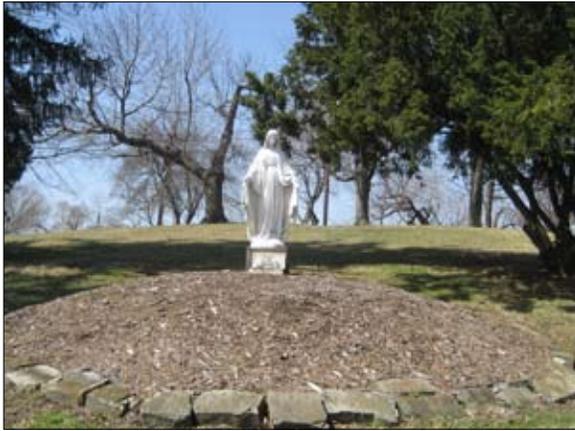
Blessed Virgin Mary – Our Lady of the Rocks

Our Lady of the Rocks statue is currently surrounded by a bed of mulch, with most of the rocks having been moved or buried. Archivist Bill Black has discovered a buried flagstone path around the site, and old photos show how the statue once appeared. Consideration should be given to restoring this feature with a rock garden base, providing upkeep can be maintained. This would create a renewed focal point in this area. (The St. Francis statue at another location shows how attractive this can be.) Alternately, large rocks could be added and ground cover planted in the bed to improve the overall aesthetic.

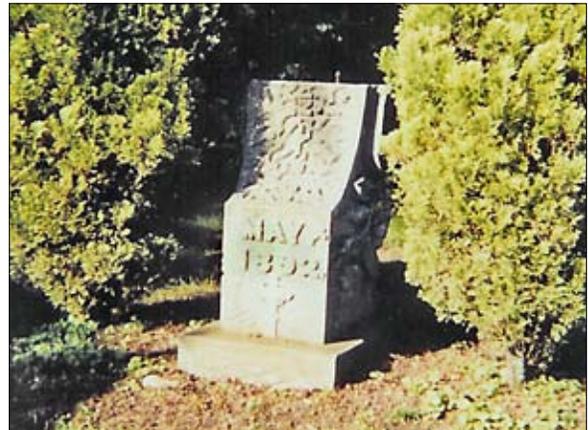
Base of the Angel

A statue known as the The Angel was recently rediscovered thanks to knowledgeable maintenance workers and is currently located in the archives. Restoration of this attractive sculpture should be undertaken and the sculpture should be reunited with its base. The base carries the date May 1892, suggesting a long history for this sculpture.

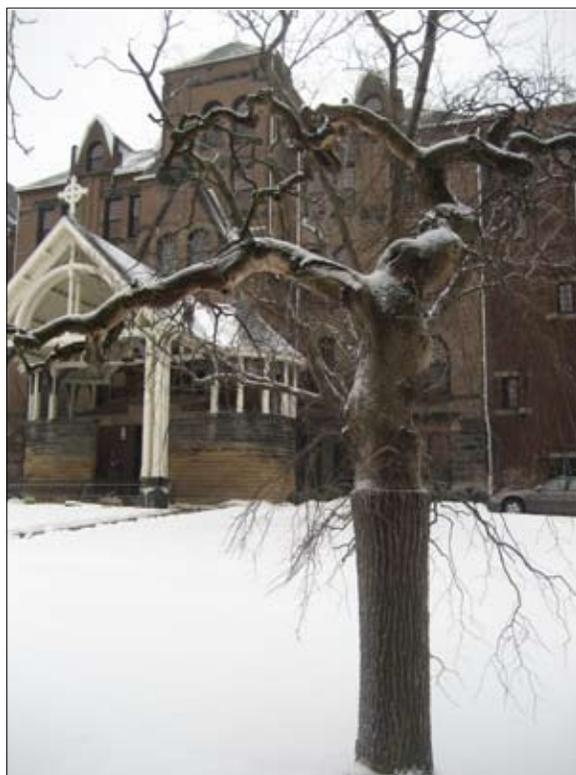
Winter Camperdown

The Camperdown elms (*Ulmus glabra* 'Camperdownii') are unusual specimens and are seen in campus photos from the early 1900's. This was a popular novelty tree with plant collectors in the Victorian era. The top portion is derived from a ground-hugging mutant branch that was first discovered at Camperdown House in Scotland around 1834-1840. It is generally grafted to a wych elm base to give it height. The graft is clearly visible due to the different bark textures, making this an interesting item for the biology student and the curious. These trees are aged and show signs of decline. Replacement trees should be planted to ensure continued representation on campus. Existing trees should be treated and maintained as long as is feasible. New trees should be planted in such a manner as to not interfere with views and sightlines.

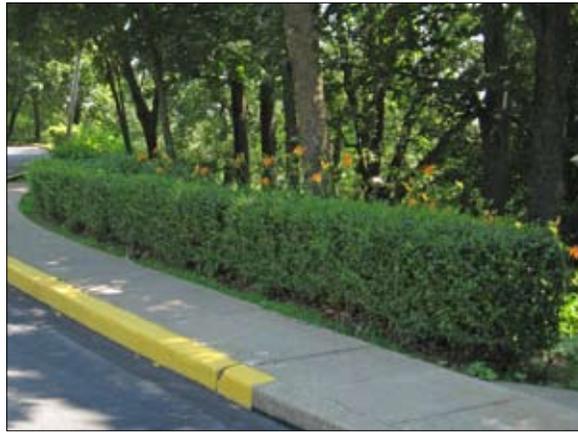
Hedge

Remnants of a privet hedge exist along the entry drive to the right. This hedge gets thin and patchy in the center due to heavy shade. The hedge is attractive where thick and creates a nice separation from the woods beyond, creating a more formal entry area. Keep hedge where thick in sun, remove remainder where it becomes thin, or thin trees slightly in this area to allow more light through.

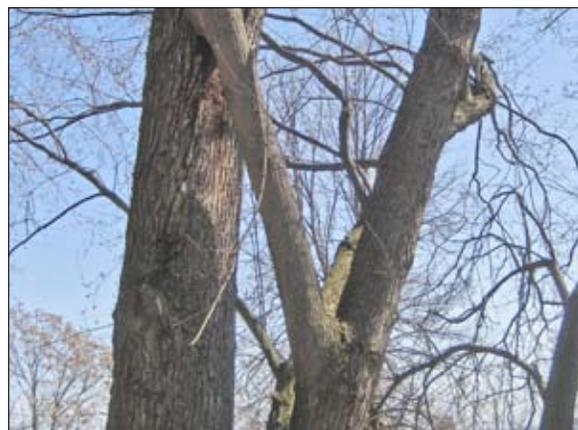
Yellowwood in winter.

Large yellowwood (*Cladrastis lutea*) is a beautiful specimen with significant decay. Poor pruning practices have allowed rot to enter main trunk. The tree appears to have been top-pruned in the past. This tree will require eventual removal and plans should be made for replacement trees.

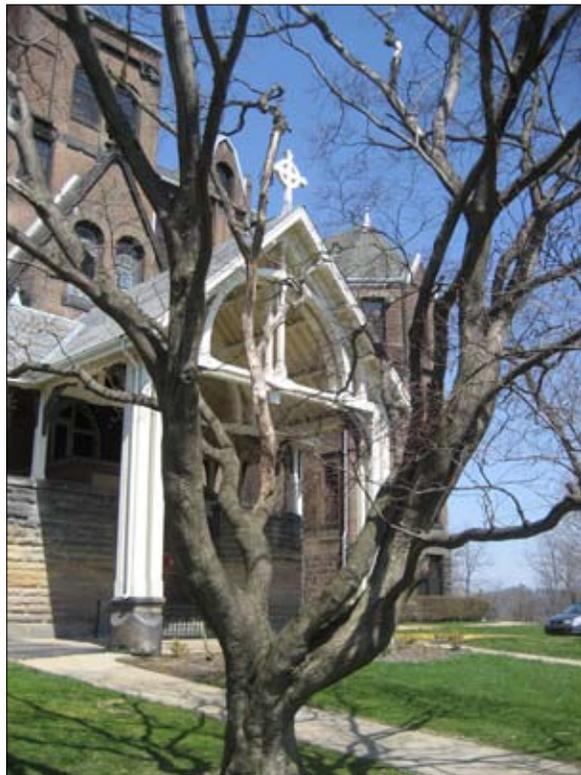
Japanese Maple

A large red-leafed Japanese maple has dead branches and rot advancing toward the main trunk. Prune dead wood at branch collars to allow the tree to seal its wounds.

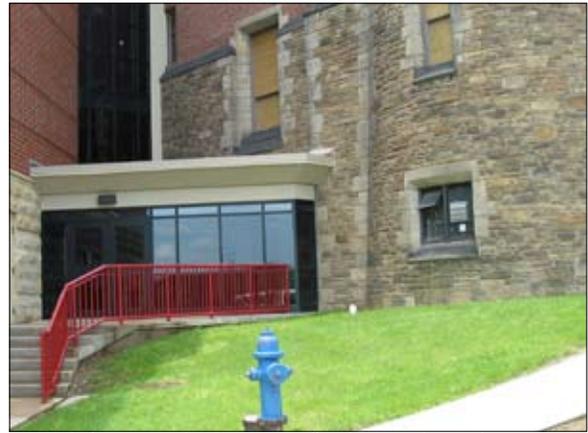
New stairs are not ADA compliant. An at-grade walkway could have been attached at the upper elevation, thus eliminating the need for costly steps.

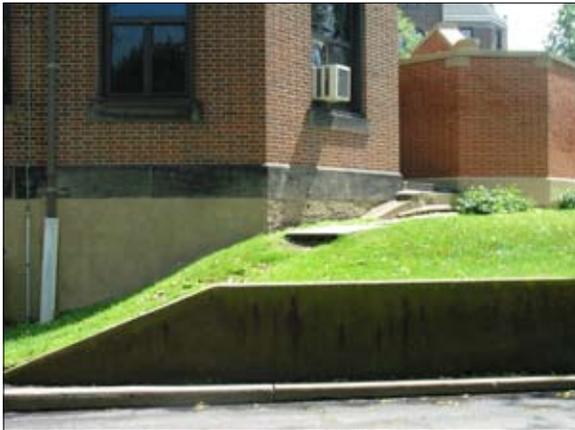
Sidewalks not contiguous

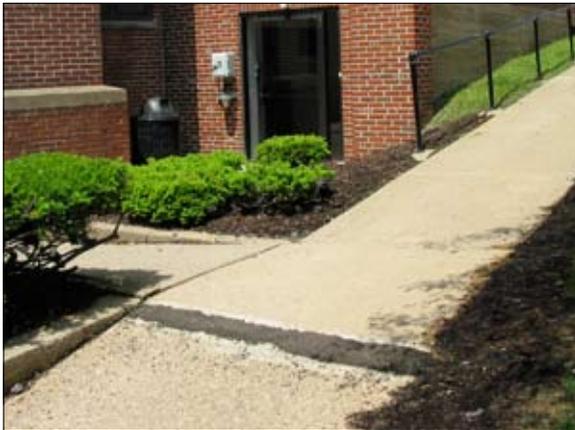
Irregular elevations and incomplete handrail

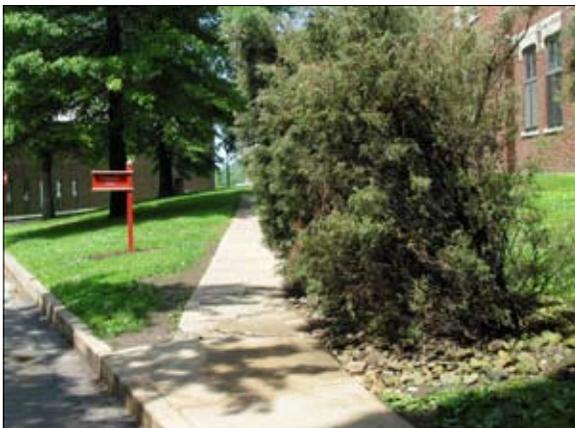
Narrow sidewalks due to overgrowth.

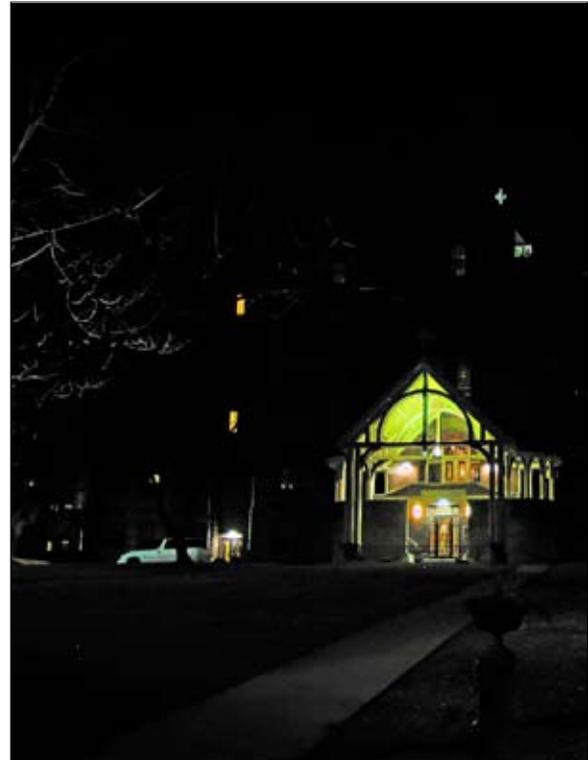
Lighted portico should be complimented by lighting the entire facade of the Admissions Building, which now is lost in total darkness.

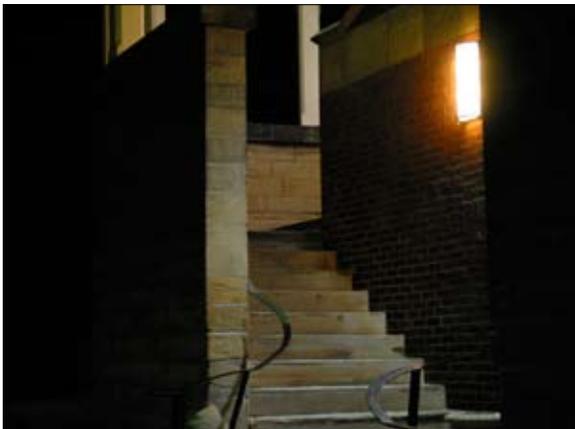
Eliminate dark stairs by lighting the building architecture.

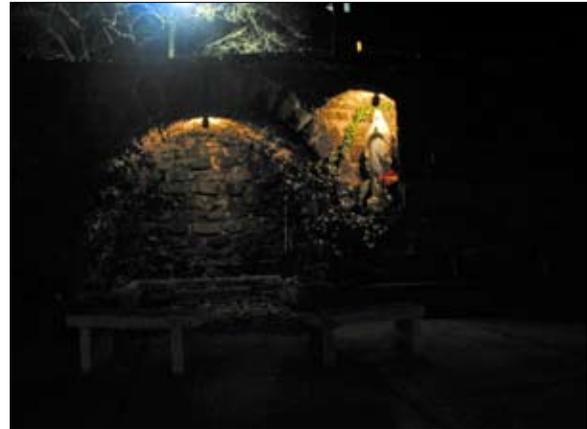
Consider more even light in Grotto, hide fixtures.

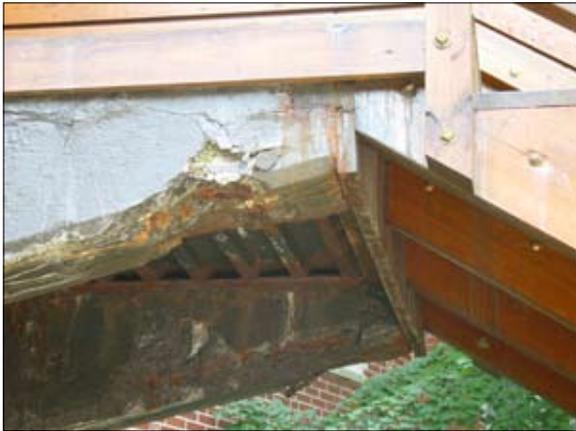
Damage due to de-icing agents.

- Repair damaged concrete at entrance doors.
- Avoid the use of sodium and calcium chlorides for deicing due to the damaging effects on concrete and steel. Urea is a less damaging material and also contains nitrogen which may be beneficial to landscape.
- Remove extraneous hardware from masonry which eventually will rust and spall mortar joints and stone.
- Prune back trees from windows and roof lines.

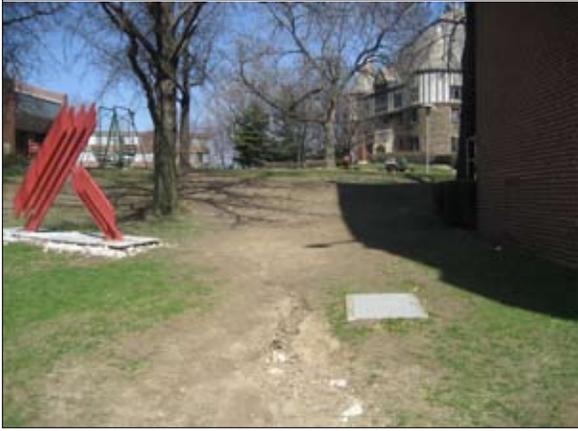
Compaction

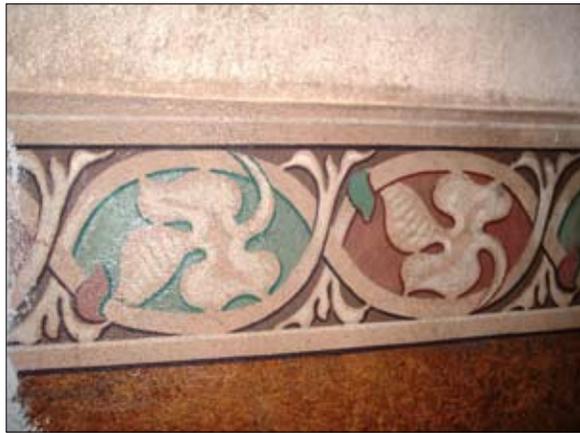
Detail of original Chapel paint uncovered in 2008

- The ground level has, over time, lost much of its original character. The reuse of the spaces on the ground level should match as much as possible the university's space needs with the original open character of the first-floor spaces.
- A portion of the original paint scheme of the chapel space is preserved behind one of the confessionals. The University should consider restoring the original paint scheme at a future time.
- For the protection of this historic structure, smoke and fire alarms should be added to the chapel and dining levels at a minimum. Ideally, fire suppression should be added to the entire structure.
- Maintain stained glass. We do not recommend outer panels which can trap heat and moisture.
- Maintain exterior masonry.

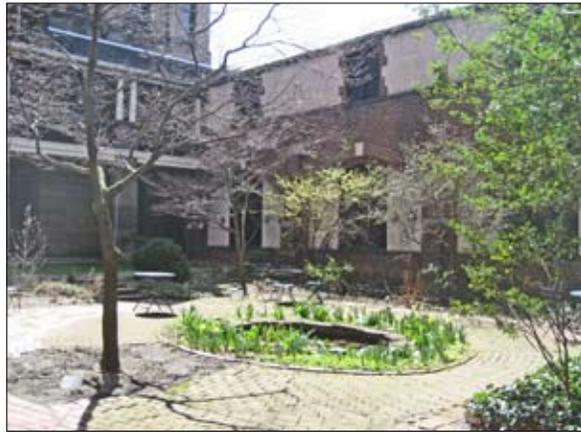
Courtyard Garden

The upper brick walk slopes and is sliding due to wash. A low retaining wall would create a level entry area, and a wider stair would make the garden more welcoming. The lower area could be slightly redesigned for better traffic flow, and an additional seating area could be developed under the American holly. Additional evergreen shrubs would create a stronger winter effect. The Havey Hall rhododendron could be moved to this garden.

Consideration should be given to a revised plan for this area. An updated planting plan and a stronger sense of structure would improve the impact of this outdoor room.

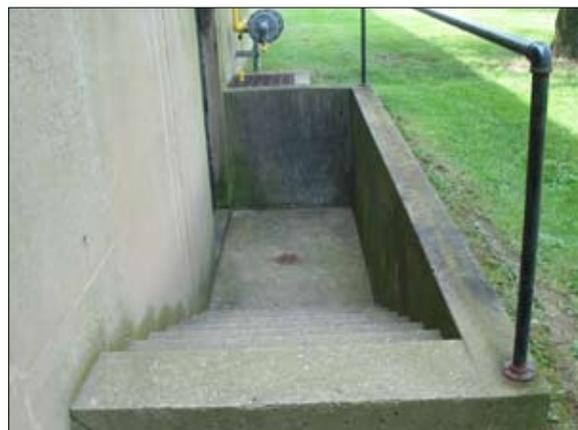
Missing stairwell hand rail

- Repair spalls in concrete by treating the rebar with a rust inhibitor and patch concrete to match existing.
- Prune tree back from window and roof line.
- Repair leaking hose bib to reduce damage to concrete.
- Repair concrete masonry at foundation.
- For safety, consider adding hand rail to stairwell leading to basement.
- Check ADA ramp for concrete spalling.

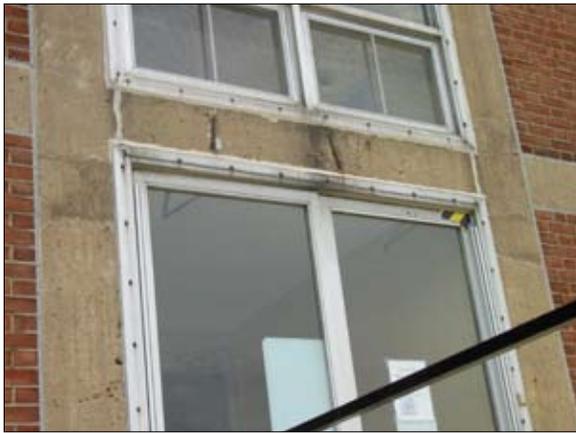
Repair spalling concrete by treating rust and patching

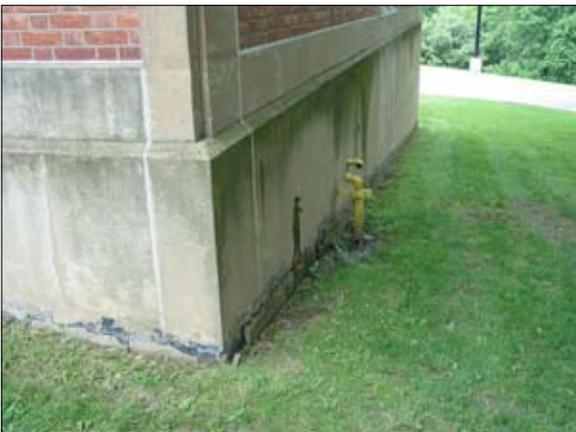
Foundation masonry requires repair

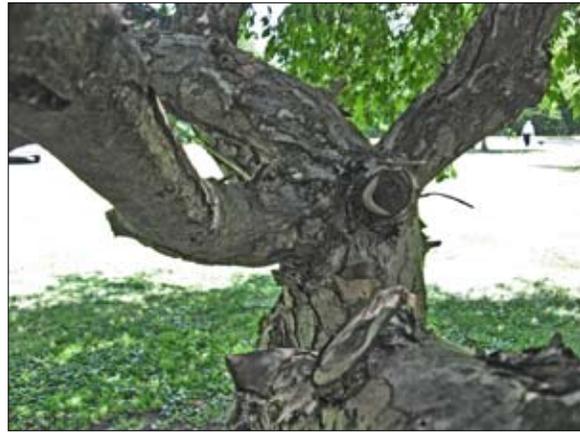
1985 crabapple: poor pruning has left stubs. Always prune to branch collars. Tree could use light pruning. Do not overprune or trees will get suckers.

Havey Crab

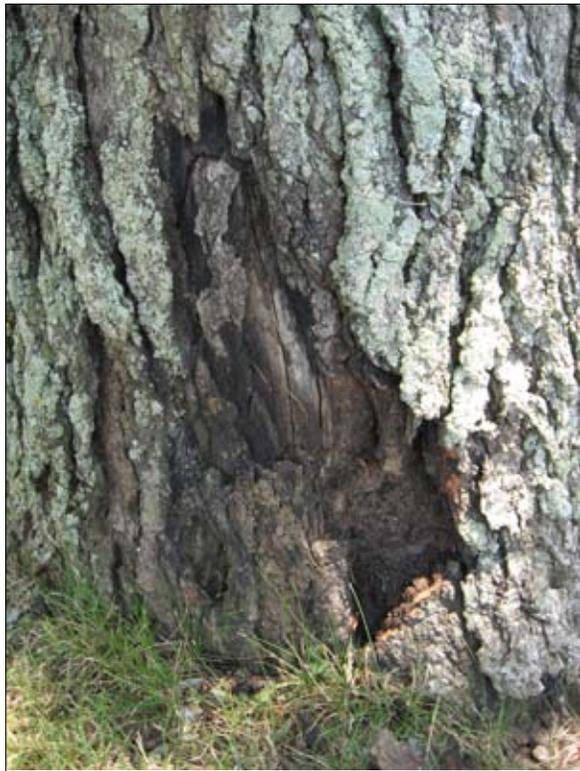
Sweetgum on northwest corner has bark damage at base. Rot is evident, bark peeling away. Possibly result of earlier mechanical damage. Have tree evaluated for soundness. Use caution around trees with mowers and trimmers.

Havey Sweetgum

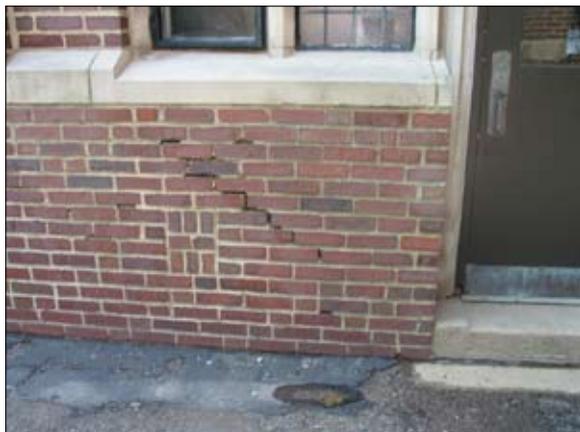
Re-point failing masonry joints

- Remove any extraneous hardware.
- Re-glaze window glass, scrape, prime and paint steel casement windows.
- Re-point masonry joint as needed.

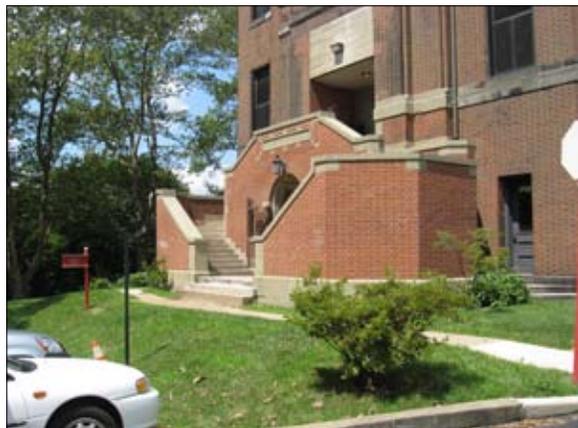
South side of Maura landscape

There is minimal planting on the south side of Maura. Single azalea has lacebug infestation. Treat azalea, consider adding small flowering trees to slope area. Add additional peonies to create mass near single existing plant.

Current sidewalk is lower than original sidewalk, leaving the lower part of foundation exposed and the first step too high. Redo sidewalk and add additional step. Consider a low hedge along the foundation or perhaps groundcover to dress up edge.

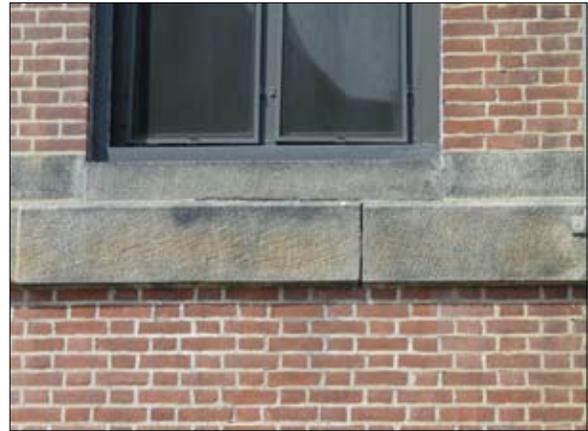
Grout joints in stone work as needed

- Repair wooden soffit, fascia and cornice brackets, then scrape, prime and paint.
- Re-point masonry joints as needed to match color, texture and size as original.
- Grout joints in stone work as needed.
- Return stone to original if possible or repair decorative cement overlay.

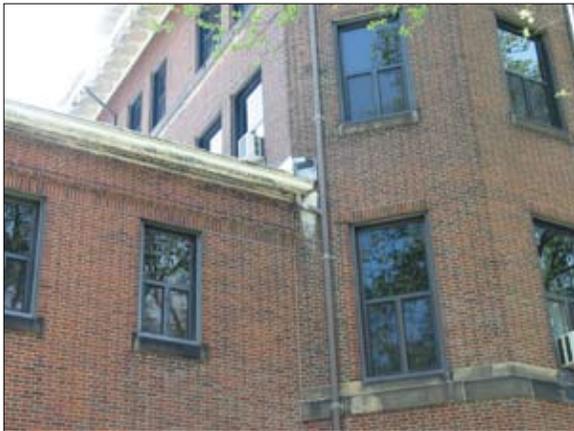
Clean masonry as needed

- Do not use any abrasive cleanings or masonry sealers on brick or stone.
- Cap abandoned rain leader.
- Consider painting new downspout to match existing.
- Clean masonry as needed.

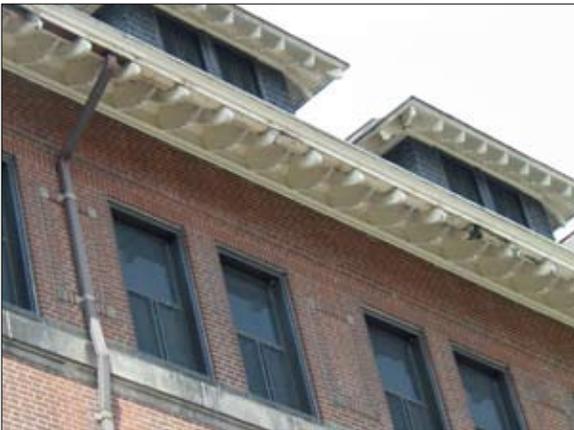
Repair & repaint wooden soffit, fascia, cornice brackets

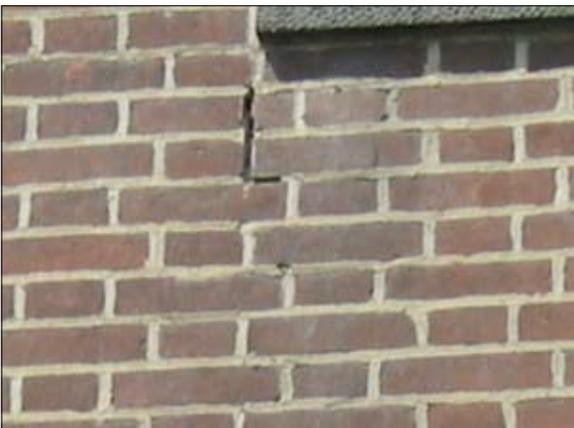
Re-point, match color and texture of failing masonry

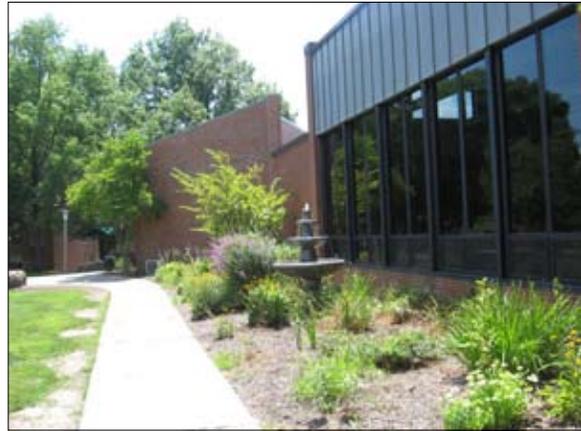
Reeves garden

Garden is too large for the number of plants within and would benefit from a stronger structure. Bindweed, sedge, seedling maples, and crabgrass were noted in beds, suggesting it is too much garden to manage with available resources. Consider reducing size of garden by introducing some lawn area to this side of walk, perhaps as broad curves.

Boxwood hedges would help define garden and give winter character. ‘Green Gem’ boxwood grows to 2’ x 2’ and would need minimal pruning. At 18” spacing or less it would make a dense hedge and create an evergreen base for the seasonal perennials behind. An updated landscape plan should be prepared for this area.

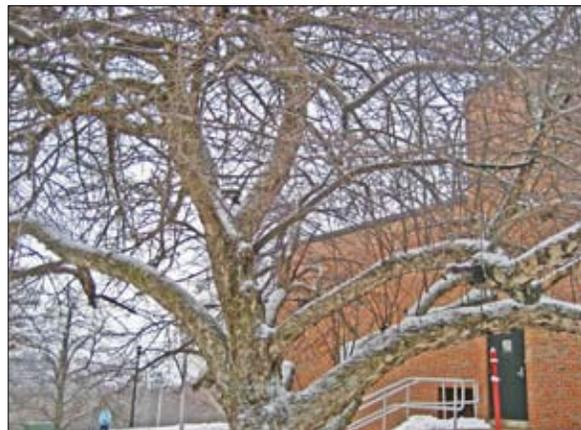
Reeves crabapple

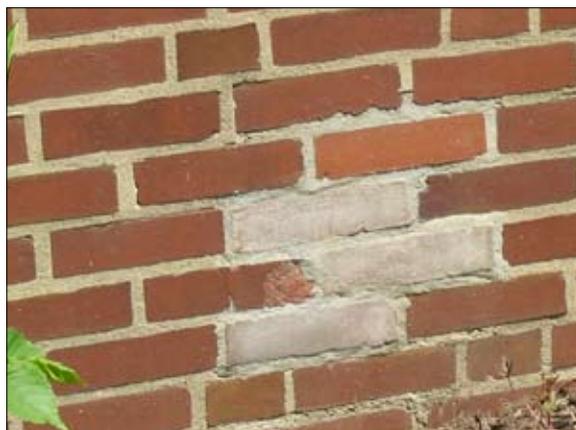
Do not repair brick and mortar with dissimilar materials

- Scrape, prime and paint wooden windows as needed.
- Repair steel window lintels that are salvageable. Should be thoroughly cleaned and treated with a rust inhibitor, primed and painted. This work should be a priority.
- Replace failing steel window lintels. This work should be a priority.
- Repair mortar joints damaged by rusting window lintels.
- Remove all extraneous hardware such as abandoned electrical services.
- When making repairs to brick masonry and mortar joints, do so with like materials.

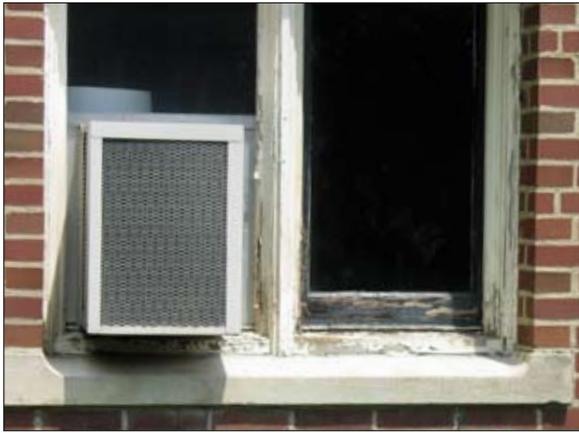
Scrape, prime and paint wooden windows

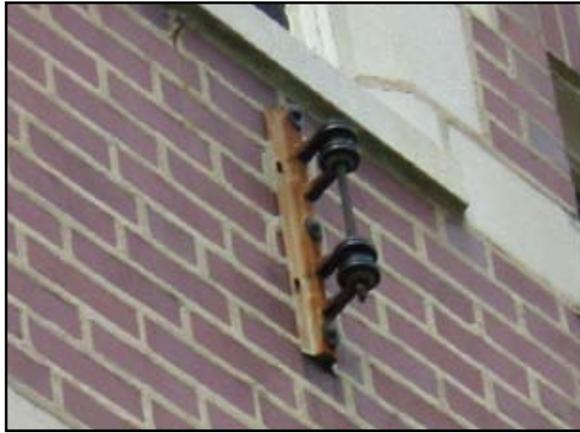
Remove abandoned hardware to mitigate damage

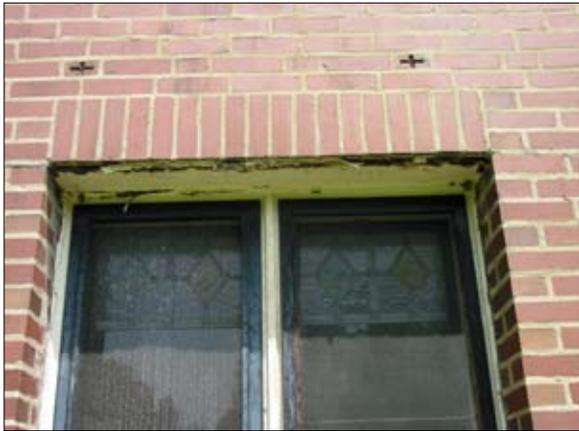
Lintels require immediate attention.

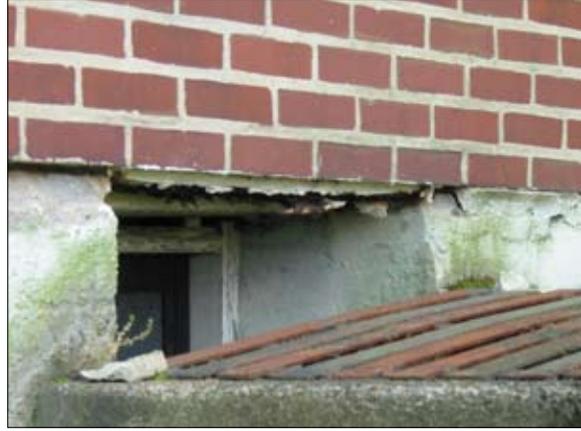
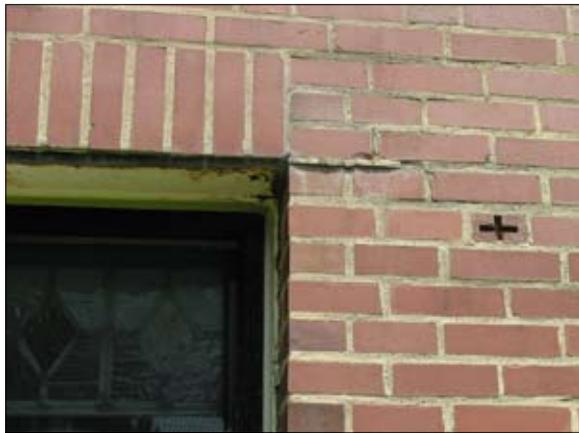
Repair mortar joints damaged by rusting lintels

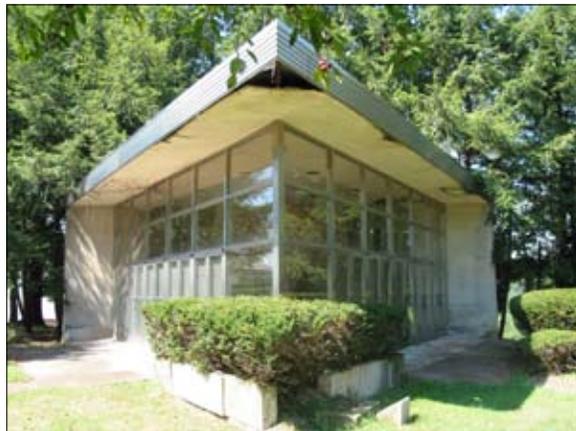
Prune back trees from roof line

- Prune back trees from roof line.
- Repair or replace roof line and cross.
- Repair or replace soffit panels.
- Repair roofing.
- Replace broken door glass.
- Reconnect downspout to rain leader.

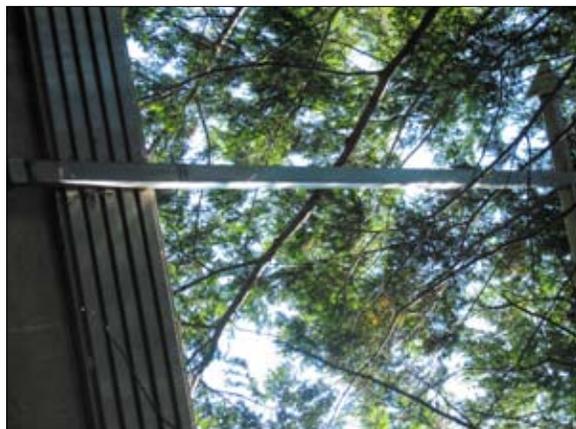
Repair or replace roof line and cross

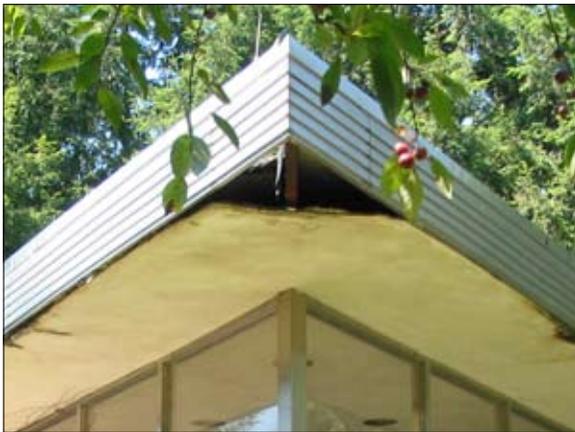
Repair or replace soffit panels

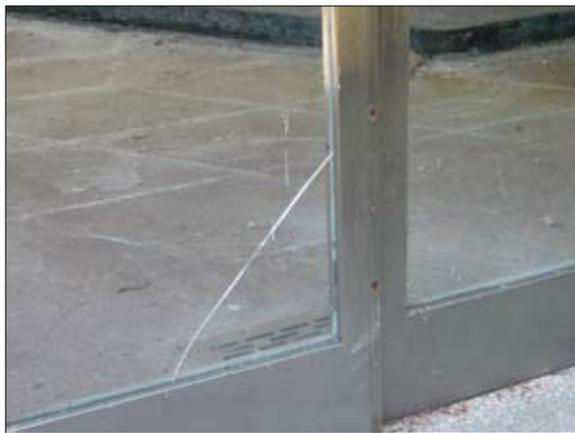
Replace broken door glass

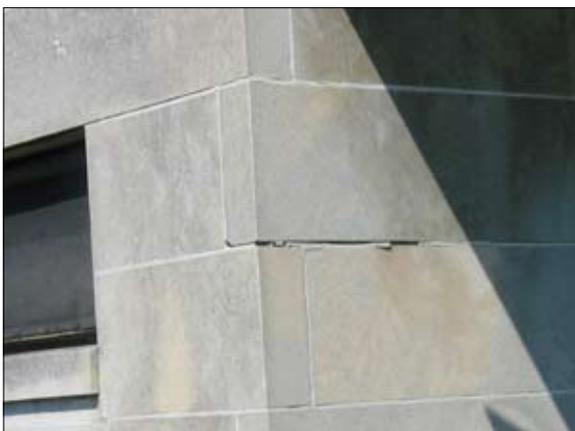
Re-point and match masonry color and texture

- Re-point masonry as needed to match original in color, size and texture.
- Repair masonry stone as needed
- Scrape, prime and paint all window lintels.

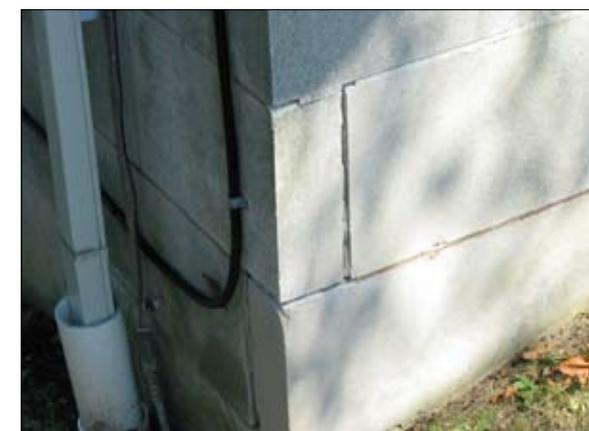
Re-point and match masonry color and texture

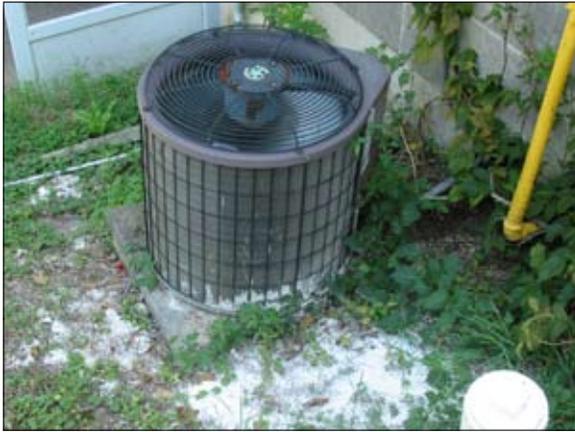
Conserve energy and enhance performance by clean HVAC condensing unit

- To conserve energy and enhance performance, clean HVAC condensing unit.
- When possible, restore all walks so that rain water drains away from building foundation.
- Check to be sure all gutters are clear and rain leaders are flowing.

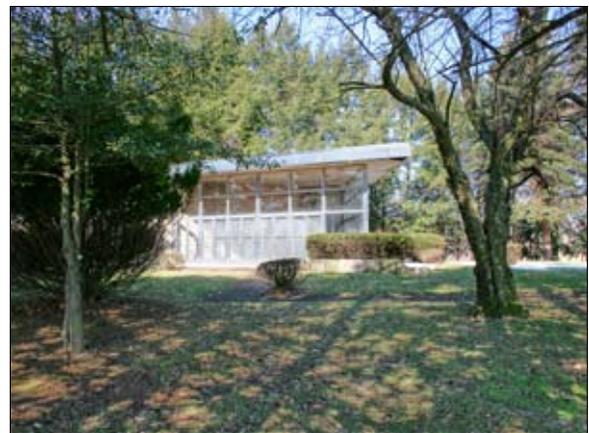
There are nice mature trees in this area but they are overwhelmed by the large number of evergreens, making the area dark, dense and somewhat funereal. Some thinning and removal of the less-healthy and less-desirable trees would improve the conditions for the remaining trees and allow more light to reach the ground plane.

St. Philomena landscape

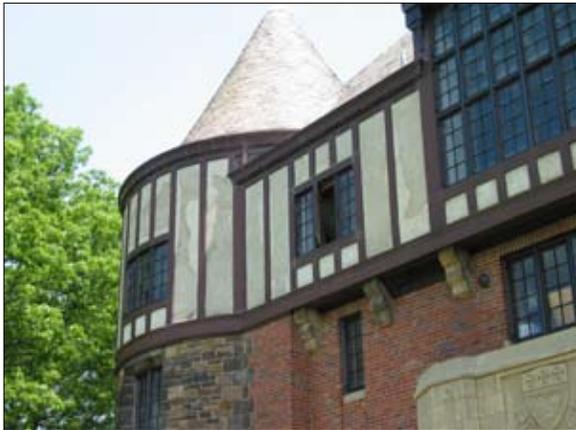
Repair stucco as needed

- Repair stucco as needed.
- Repair stone as needed with proper materials.
- Remove abandoned copper tubing.

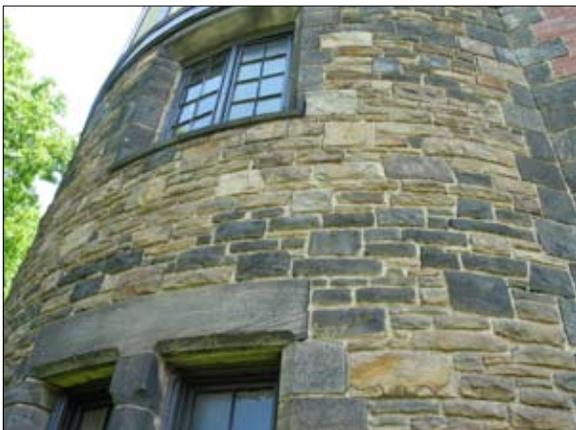
Re-point as needed to match existing

- Re-point as needed to match existing.
- Check kitchen exhaust for proper operation, clean masonry as needed.
- Scrape, prime and paint windows as needed.
- Repair stone window sills.

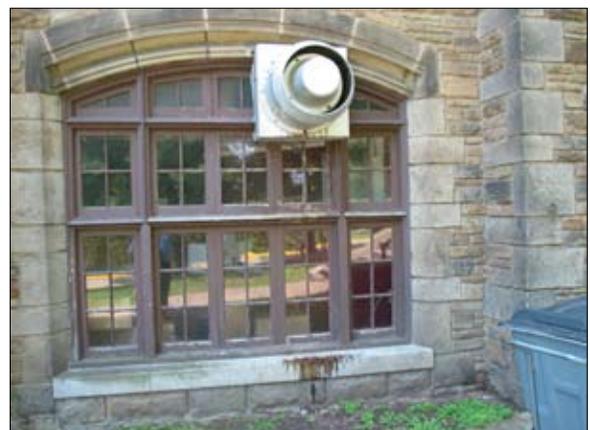
Inspect kitchen exhaust, clean masonry as needed

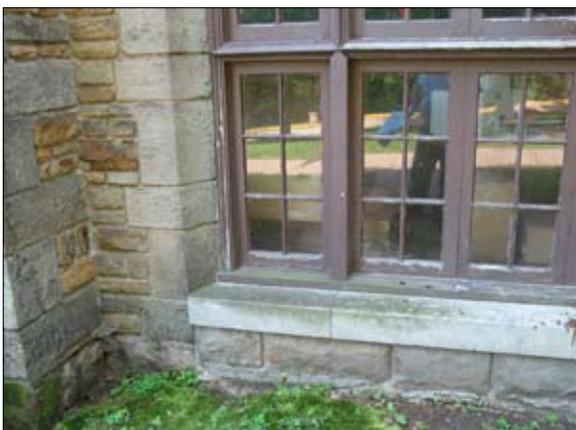
Scrape, prime and paint windows as needed

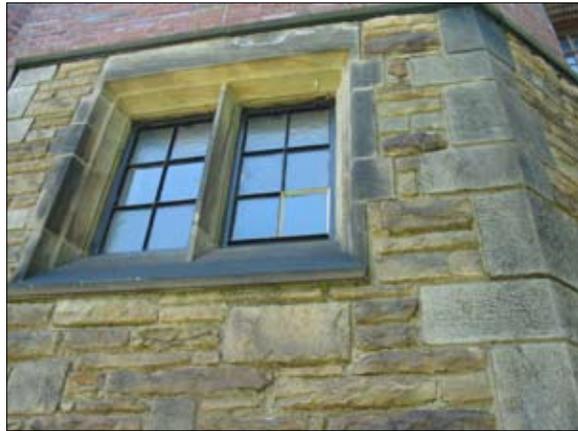
Scrape, prime and paint windows as needed

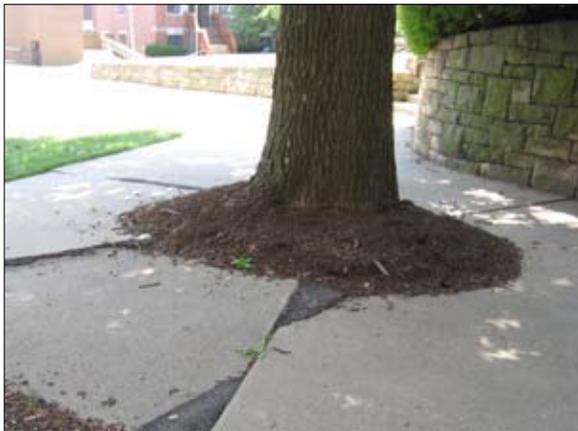
Large sweetgum has constricted planting bed, creating sidewalk heave. Adjust sidewalk to allow bigger ring around base of tree, ensure the root flare has adequate room. Mulch right at trunk of tree is contributing to rot. Keep mulch away from tree trunks.

Tree mulched too thick. Consider expanding outward.

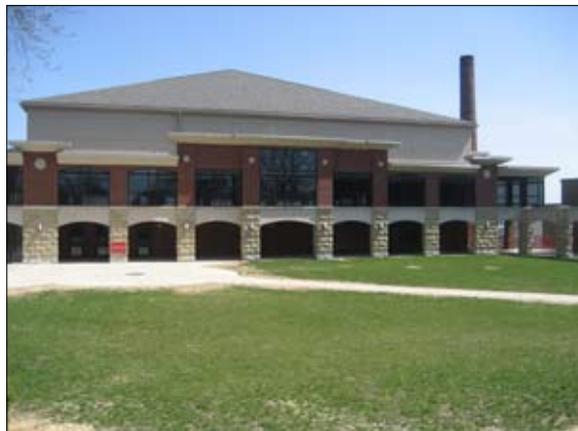
Lawn area in front of Mabis McKenna Center would benefit from canopy trees.

Area would benefit with canopy tree plantings.

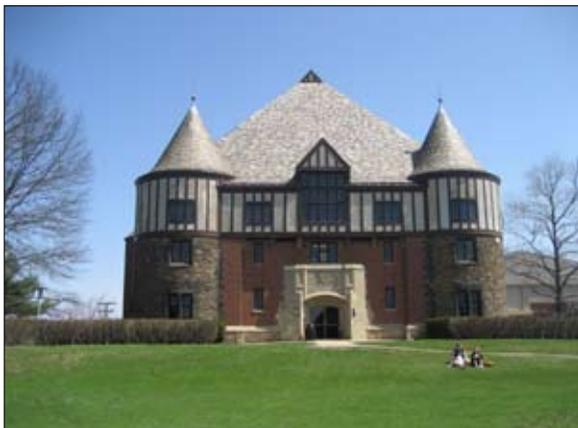
Yew and burning bush hedges are simple base plantings which highlight the building architecture. They are of good scale and create an effective setting.

Burning bush hedge was originally planted too close to sidewalk, and the building side of hedge is bare due to regular trimming necessary to keep the sidewalk open.

Hedges compliment building architecture

Consideration should be given to new hedges of more suitably-sized plants, or similar plants allowed proper room for growth. Green Velvet boxwood grows to approximately 4' x 4' and would be a suitable replacement for the burning bush hedge. The yew hedge could be trimmed back, as yew responds well to heavy pruning, or replaced with smaller evergreen plants.

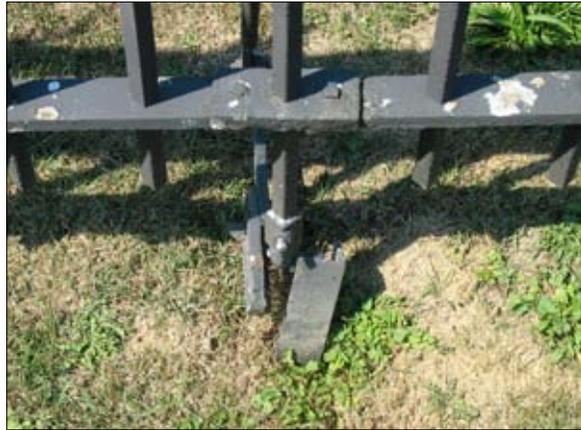
Repair or replace iron fence supporting anchors

- Repair or replace iron fence supporting anchors
- Adjust iron fencing to make it straight and plumb; this will help to relieve stress points at supporting anchors
- Scrape, prime and paint iron gates and fence

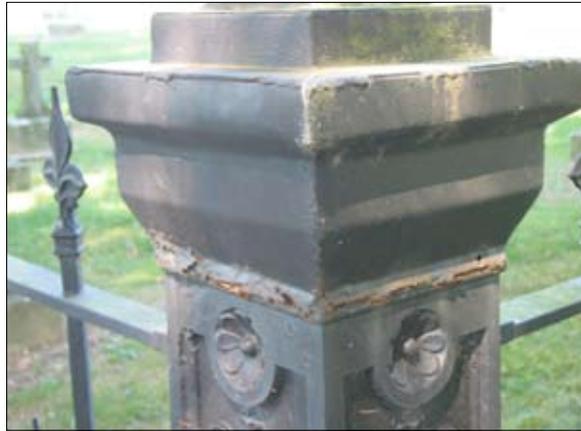
Scrape, prime and paint iron gates and fences

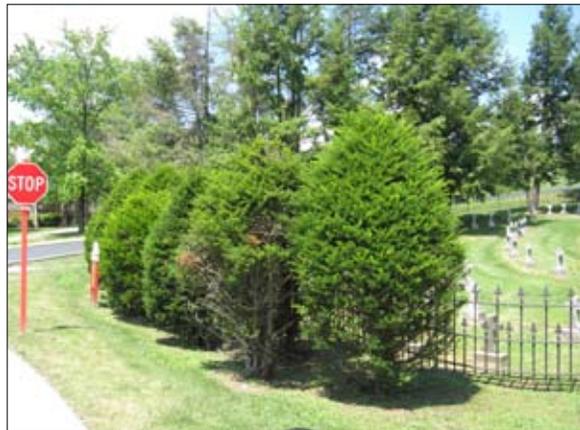
Cemetery yews

Remove first yew bushes to left of entry gate which are in poor condition.

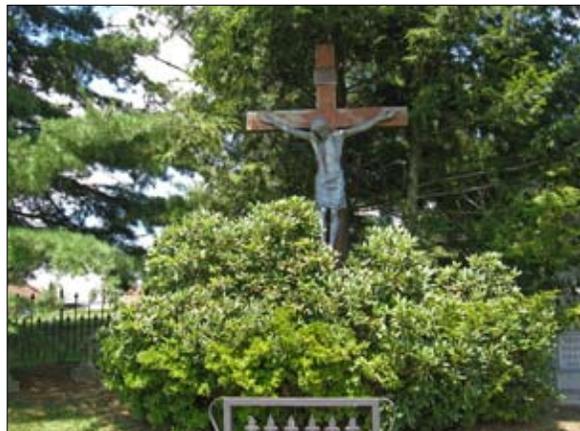
Central crucifix

Reduce crowding of plants by removing azaleas under rhododendron. Remove top 12 to 18" of rhododendron to left to match height of right. Remove lowest branches of right-most hemlock, which are sticking out from within rhododendron. Clean up stub-pruning on hemlock.

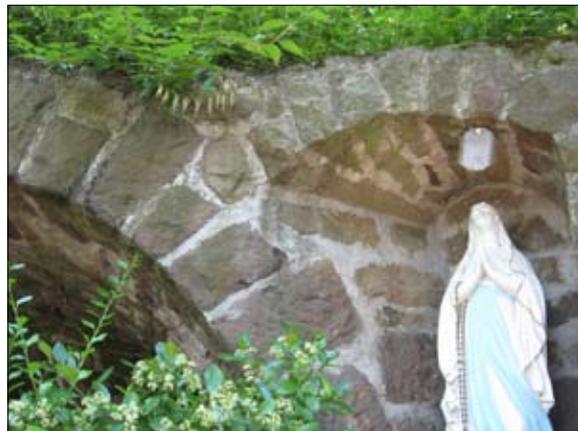
Mortar repairs are lighter than the old mortar and in contrast to the mellow color of the stone. Mortar could be tinted for a better match, or ideally, pieces of original mortar can be found and analyzed, and the new mortar made to match. Following National Park Standards for historic property repair is recommended. They can be found at http://www.nps.gov/hps/tps/standguide/preserve/preserve_masonry.htm

Mortar repair

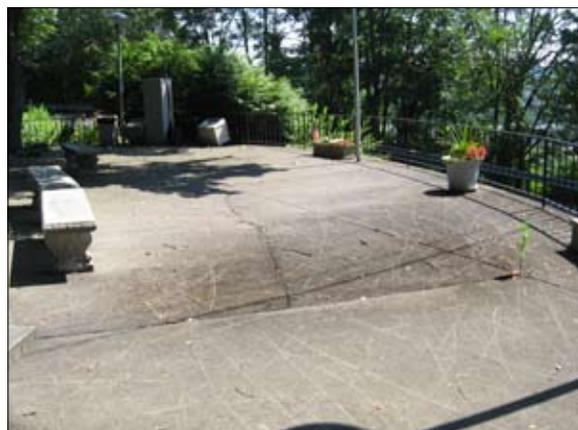
Subsidence under the patio is creating a low spot. Water gathers here and runs under patio. Water is exiting at wall, creating cracks in wall.

Patio low spot, wall cracks

Repair patio, making certain it is pitched to allow water to run off the edge, or install

underdrains to divert water.

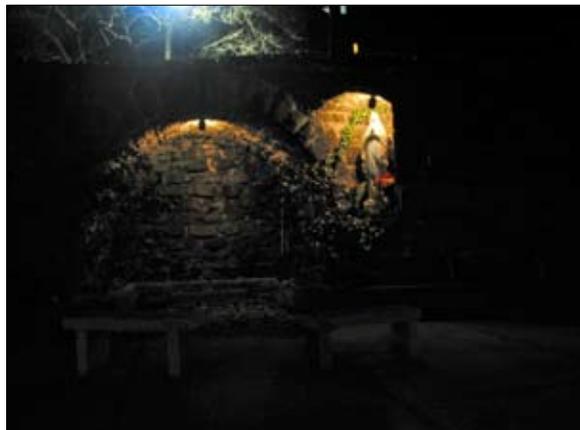
Consider more even light in the Grotto

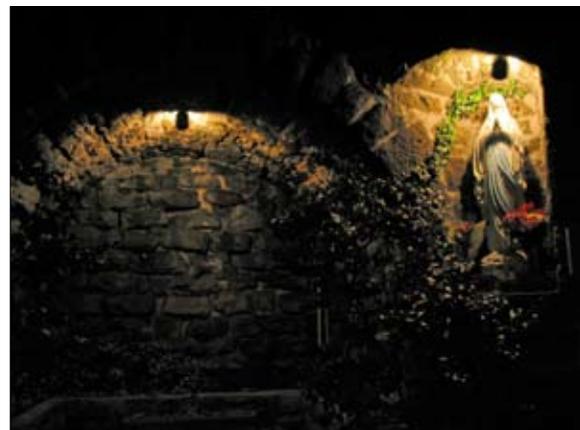
Light fixture is too conspicuous. Hide or recess.
